Duke Street Bridge over CP Railway

City of Dryden

Ref. No. JML2024090

December 2024

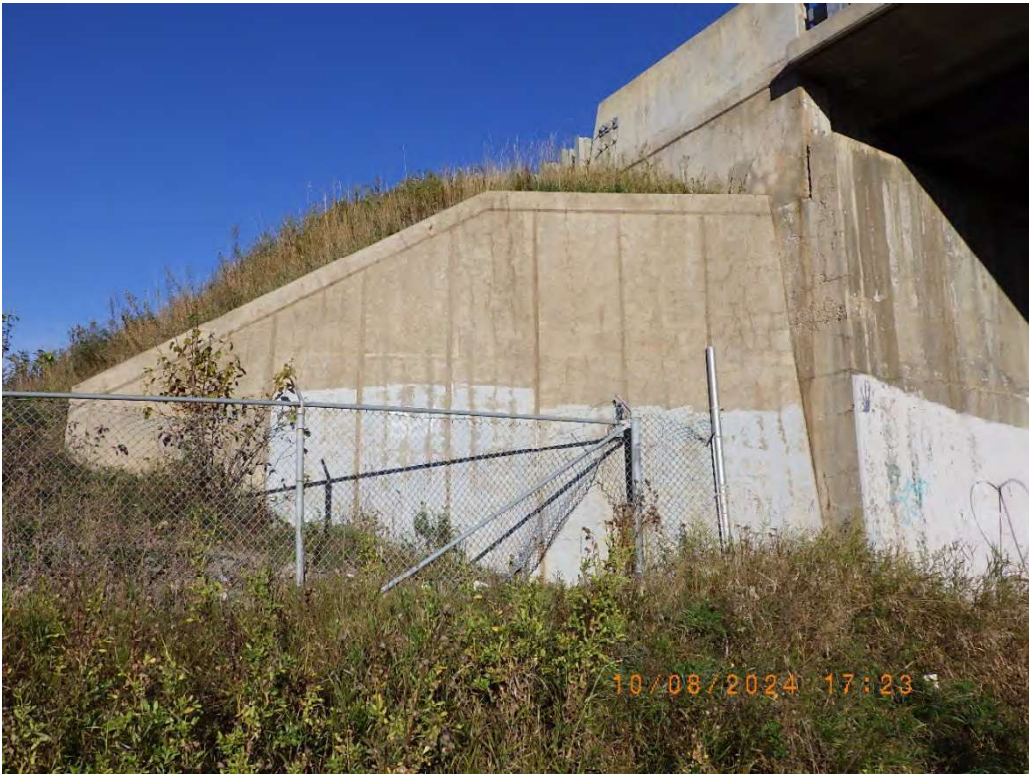
Photo 11: Northwest wingwall.

Light pattern cracking was observed throughout the northwest wingwall.

Element Group:	Abutments				Length:	
Element Name:	Wingwalls				Width:	7.5 m
Location:	North Wingwall				Height:	4.8 m
Material:	Cast-in-place concrete				Count:	2
Element Type:					Total Quantity:	72 sq m
Environment:	Benign Moderate / Severe				Limited Inspection <input type="checkbox"/>	
Protection System:						Perform. Deficiencies
Condition Data:	Units	Exc.	Good	Fair	Poor	
	(m ²) m / each / % / all		67	3	2	
Comments: Large gap between wingwall and abutment wall. Light pattern cracking throughout. Scaling, medium cracks at sides at abutments.						
Recommended Work:				Maintenance Needs:		18
<input checked="" type="checkbox"/> Rehab <input type="checkbox"/> Replace <input checked="" type="checkbox"/> 1-5 years <input type="checkbox"/> 6-10 years				<input type="checkbox"/> Urgent <input type="checkbox"/> 1 year <input checked="" type="checkbox"/> 2 year		
Reface deteriorated areas				Establish a monitoring system to measure gap widths.

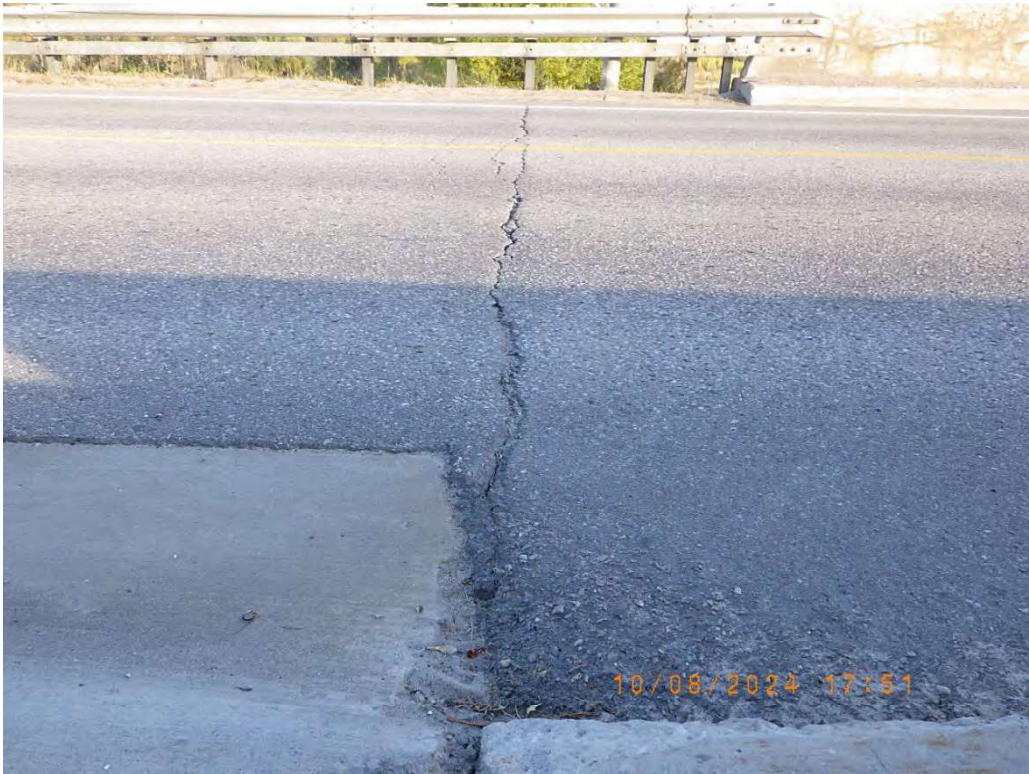
Photo 21: North approach slab joint.

A wide, full roadway width asphalt crack exists at both approach slab joints.

Element Group:	Approaches			Length:	6.1 m	
Element Name:	Wearing Surfaces			Width:	9.1 m	
Location:	North and South ends			Height:	0.075 m	
Material:	Asphalt			Count:	2	
Element Type:				Total Quantity:	111 sq m	
Environment:	Benign / Moderate / <u>Severe</u>			Limited Inspection <input type="checkbox"/>		
Protection System:						Perform. Deficiencies
Condition Data:	Units	Exc.	Good	Fair	Poor	
	(m ²) m / each / % / all		107	2	2	
Comments: Wide, full roadway width transverse crack exists at both approaches.						
Recommended Work:				Maintenance Needs:		
<input checked="" type="checkbox"/> Rehab <input type="checkbox"/> Replace <input checked="" type="checkbox"/> 1-5 years <input type="checkbox"/> 6-10 years				<input type="checkbox"/> Urgent <input type="checkbox"/> 1 year <input type="checkbox"/> 2 year		
Rout and seal cracks.

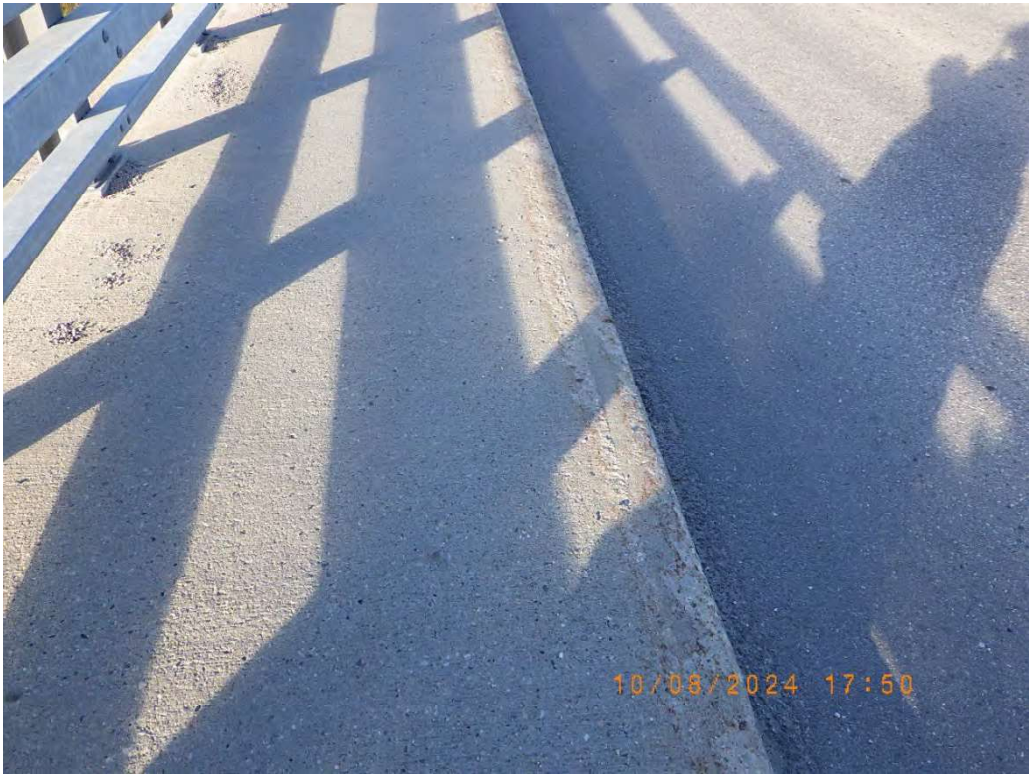
Photo 29: Abrasion damage along face and top edge of sidewalk.

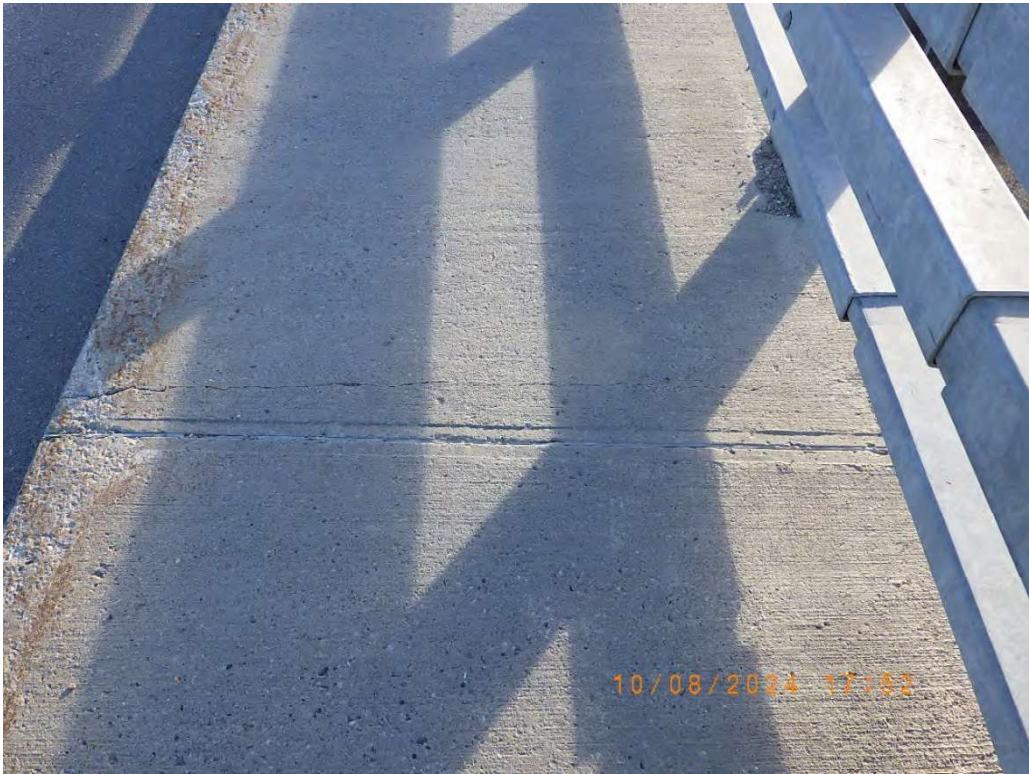
One full width medium crack and two full width narrow cracks were observed at the sidewalk.

Photo 30: Medium transverse crack in sidewalk.

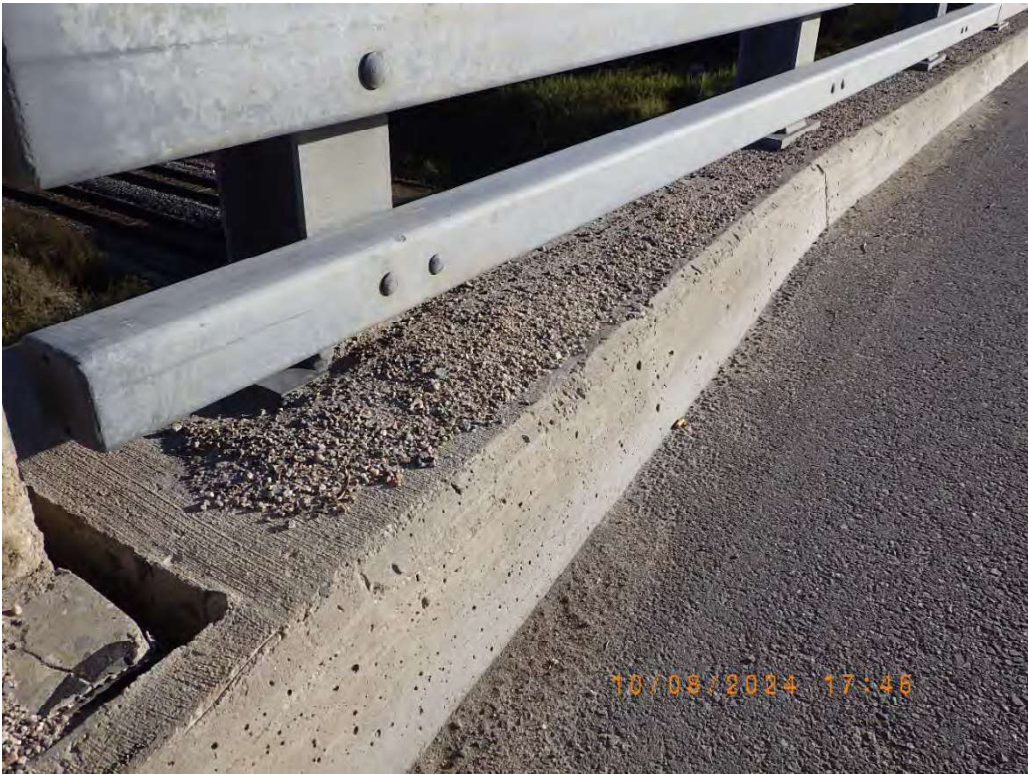
Gravel has accumulated on top of the curb at the bridge and the approaches.

Gravel has accumulated on the base plates at the east and west side railing system posts.

Photo 31: Gravel accumulation on curb and post base plates.

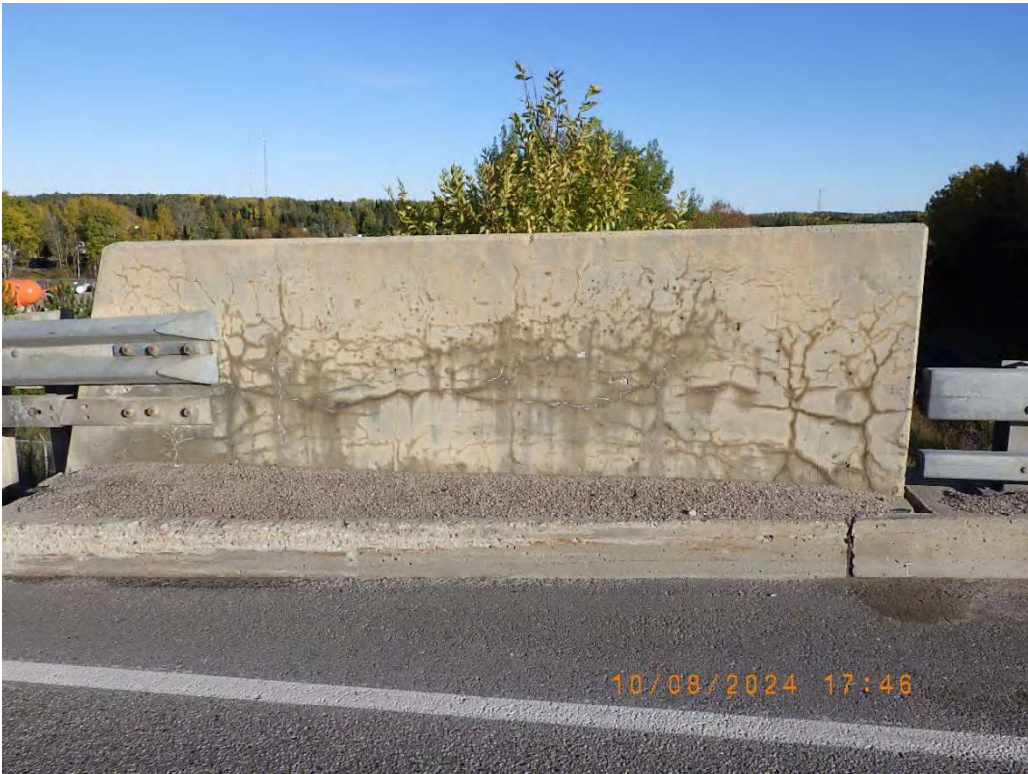
Delamination was observed at all four parapet walls. Light pattern cracking was observed at the inside faces of all parapet walls. The expansion joints have shrunk and are beginning to fail.

Photo 32: Scaling, delamination and cracks at northeast parapet wall (typ.).

Reface parapet walls. Replace expansion joints.

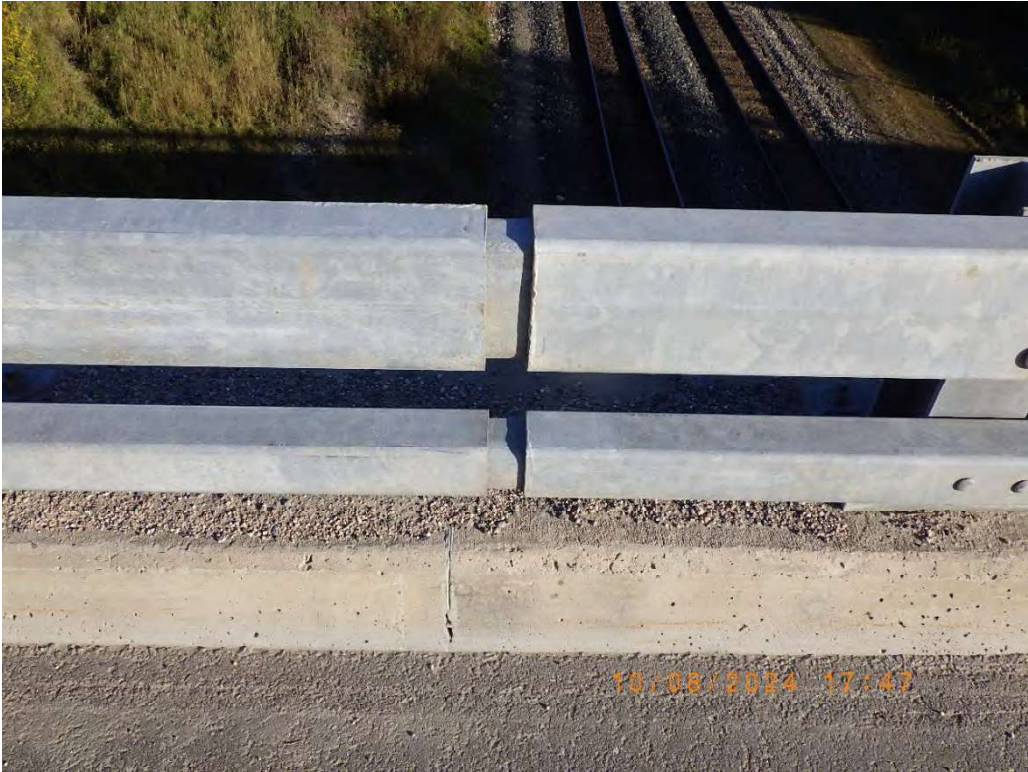
Photo 33: Wide gap at steel beam splice.

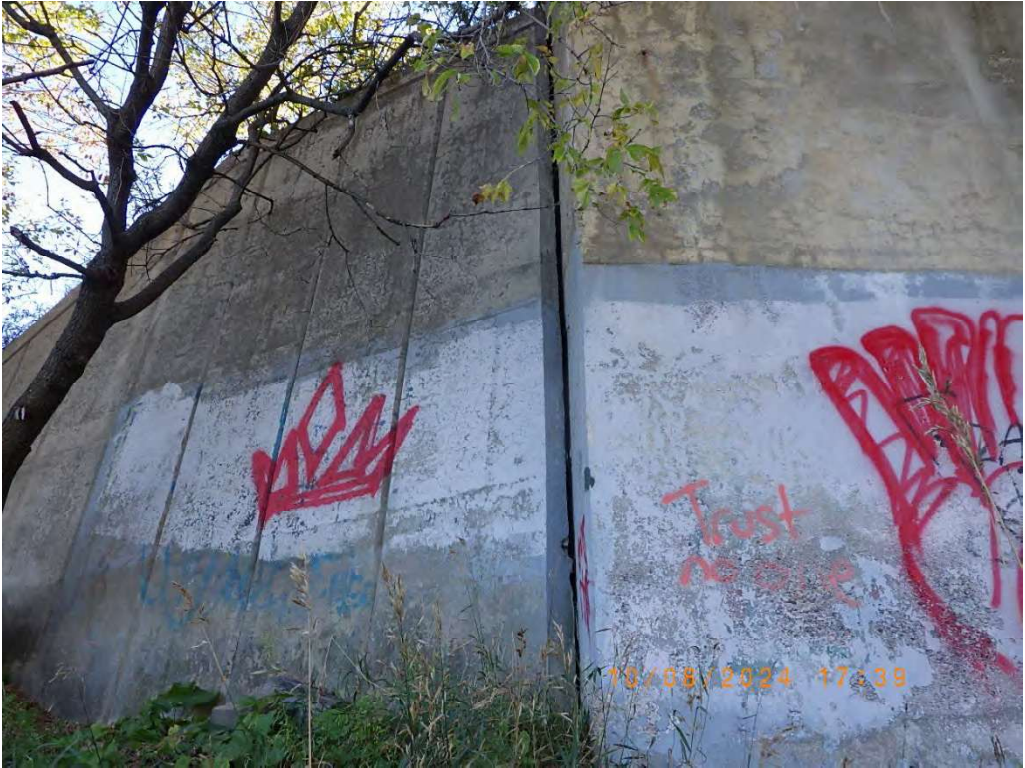
There are wide vertical gaps between the wingwalls and the sides of the abutments.

Photo 34: Wide gap between southeast wingwall and south abutment (typ.).

We recommend a monitoring system be established to measure and record the widths of the gaps between the wingwalls and abutments.

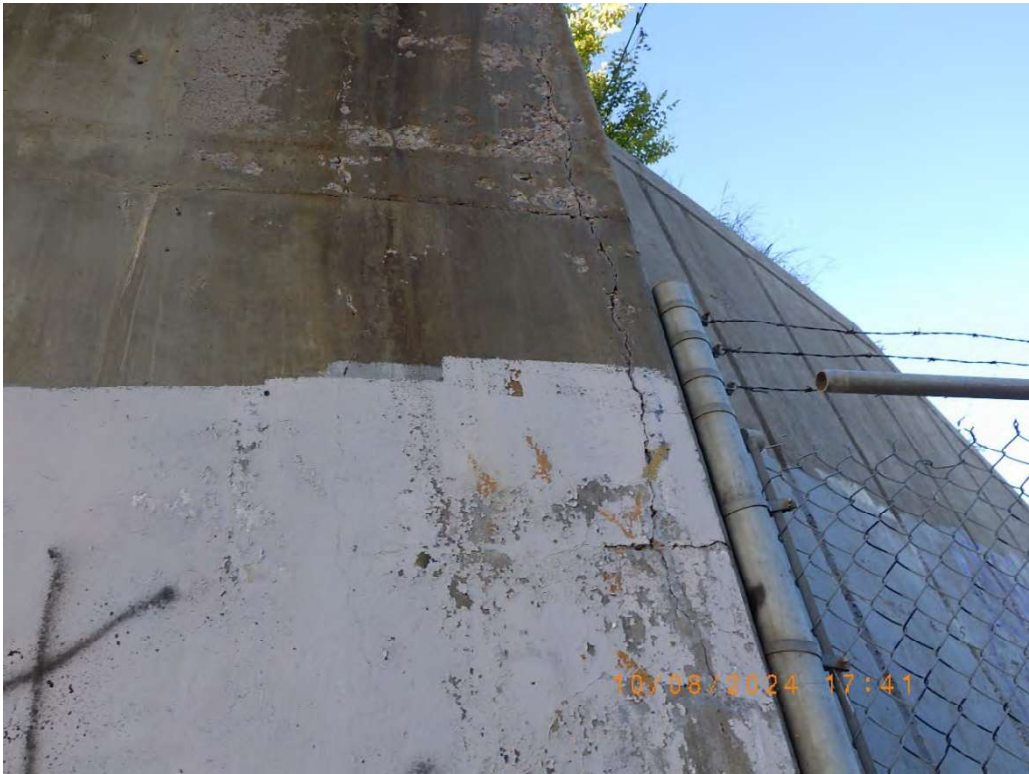
Two full height medium cracks were observed at the north and south abutments.

Photo 35: Vertical crack at north abutment.

Repair delaminated areas. Inject cracks with epoxy.				Remove graffiti paint.

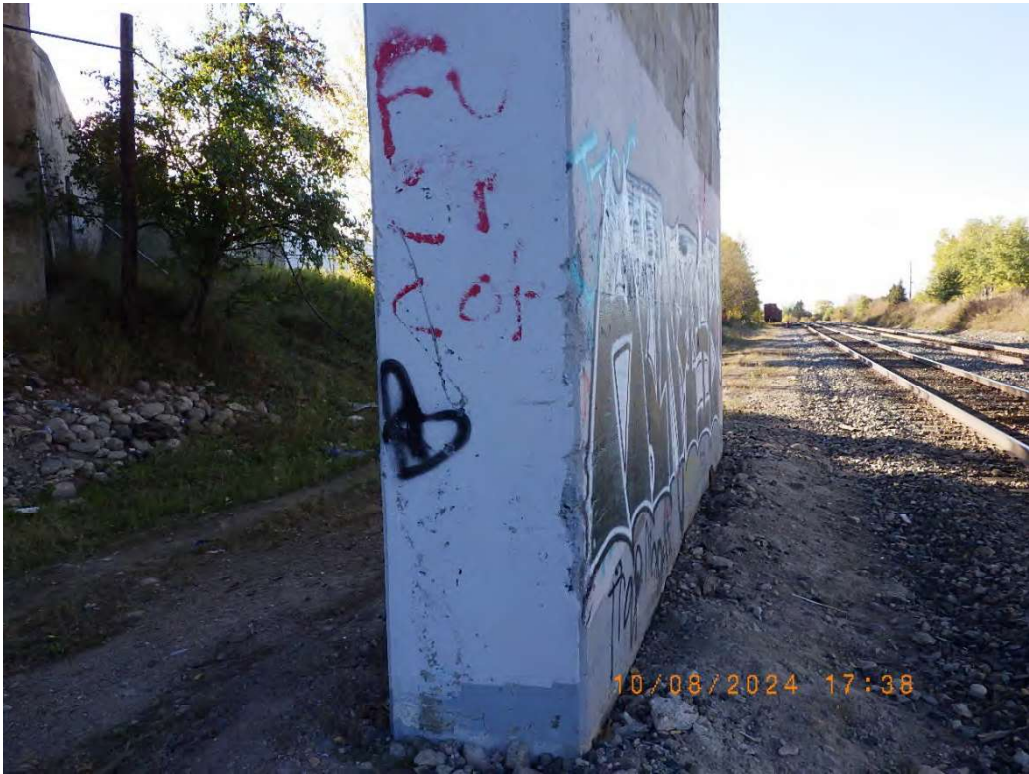
Delamination and one wide crack was observed at the south pier. A spall with exposed rebar, one area of delamination, and one wide crack was observed at the north pier.

Photo 36: Corner spalls at south pier.

Element Group:	Piers				Length:	6.1 m
Element Name:	Piers				Width:	0.69 m
Location:	South Pier				Height:	7.7 m
Material:	Cast-in-place concrete				Count:	1
Element Type:	Tee Type Pier				Total Quantity:	120 sq m
Environment:	<u>Benign</u> Moderate / Severe				Limited Inspection <input type="checkbox"/>	
Protection System:						Perform. Deficiencies
Condition Data:	Units <u>m²</u> / m / each / % / all	Exc.	Good 110	Fair 4	Poor 6	
Comments: Several patched areas. One delaminated area at north face. Delamination and wide crack at east underside. Graffiti paint on pier.						
Recommended Work:				<input checked="" type="checkbox"/> Rehab <input type="checkbox"/> Replace		Maintenance Needs:
				<input checked="" type="checkbox"/> 1-5 years <input type="checkbox"/> 6-10 years		<input type="checkbox"/> Urgent <input type="checkbox"/> 1 year <input checked="" type="checkbox"/> 2 year
Repair delaminated areas. Inject cracks with epoxy.						Remove graffiti paint.

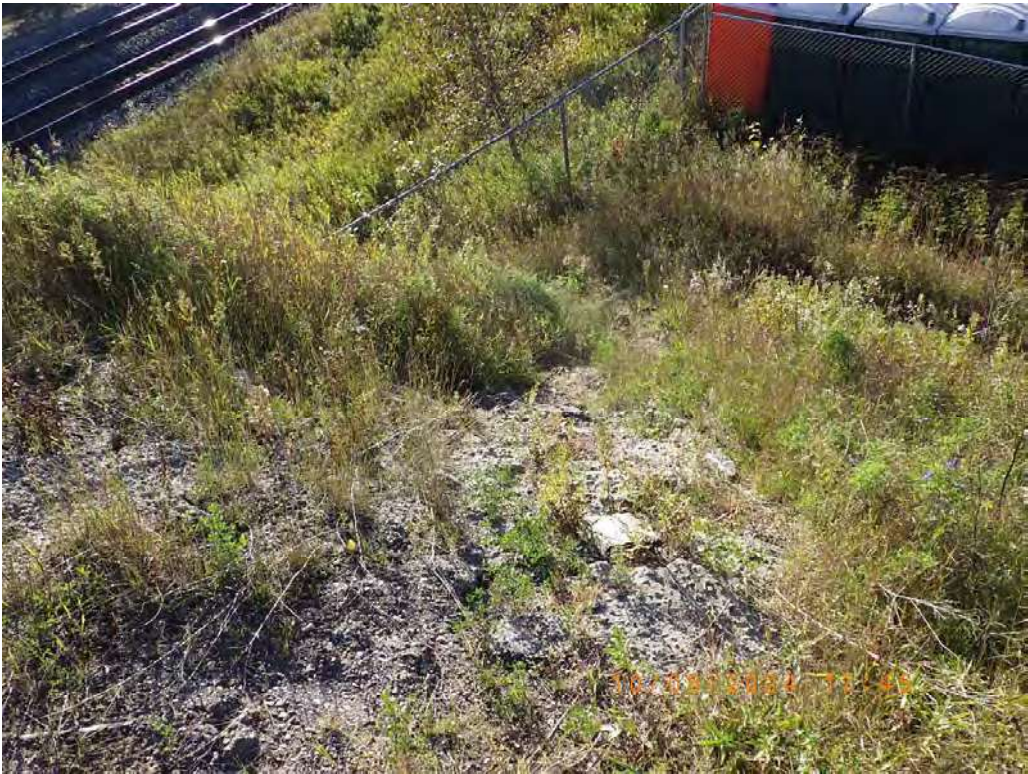
Erosion has occurred at top of embankment at southwest corner of bridge, and southeast end of

Photo 37: Erosion at embankment northwest corner of bridge.

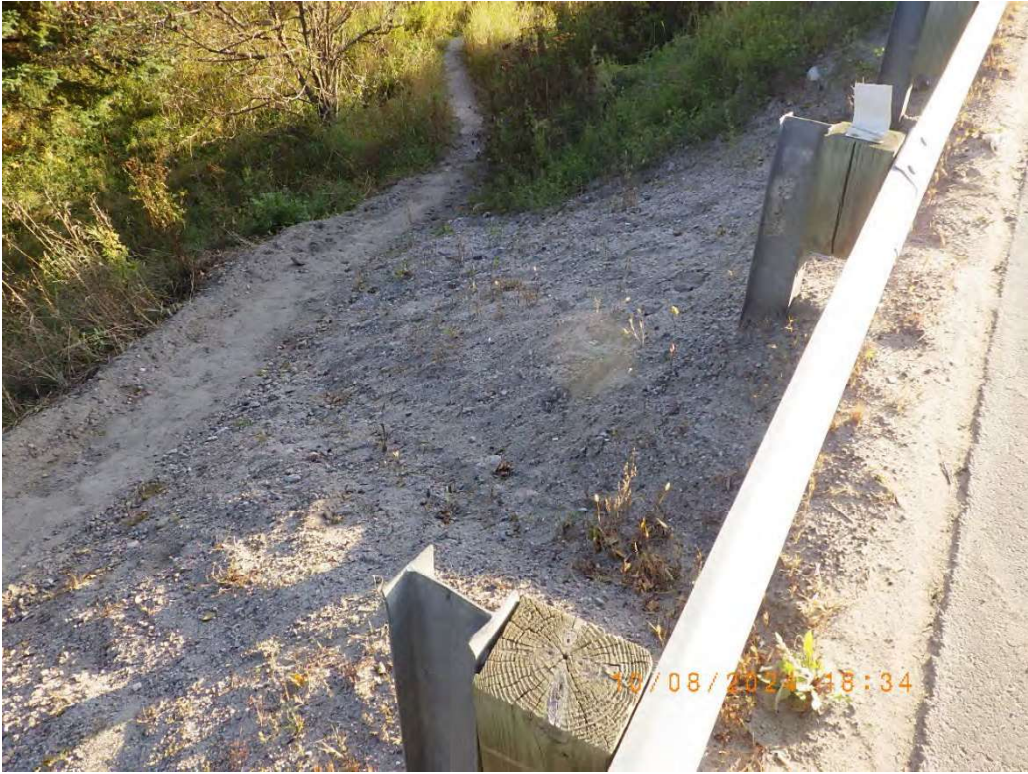
Photo 38: Erosion at embankment southeast area of site.

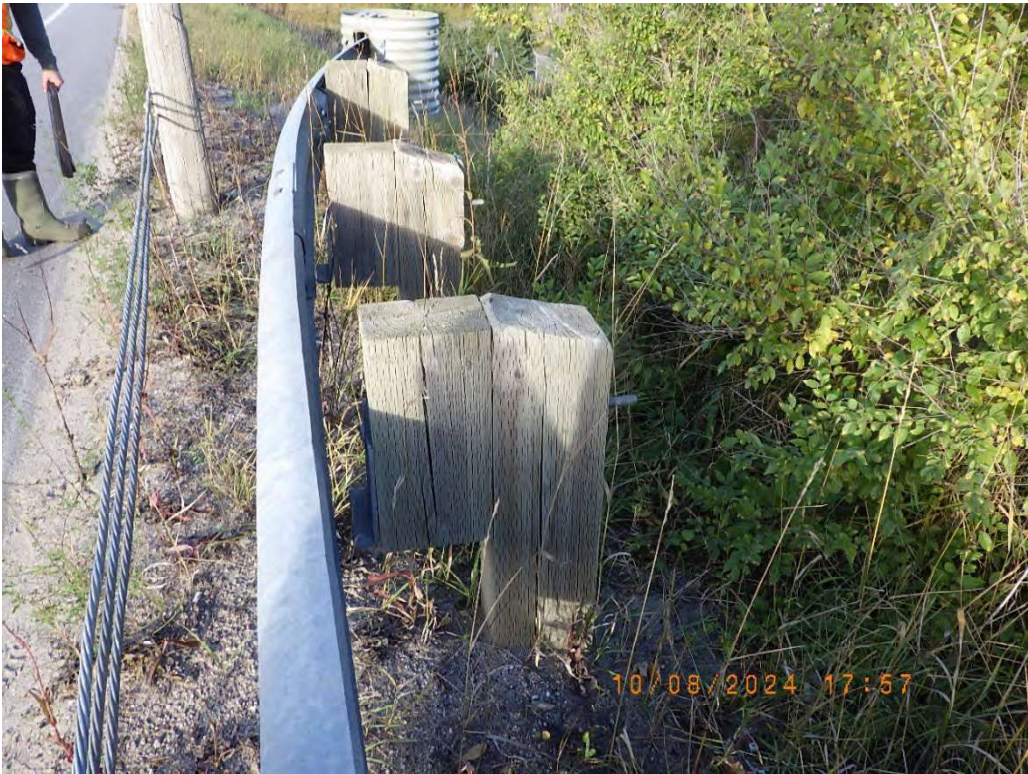
The steel beam guide rail is off clip angle shelves at end posts at northeast corner of site.

Photo 39: Steel beam guide rail off steel shelves at northeast end treatment.

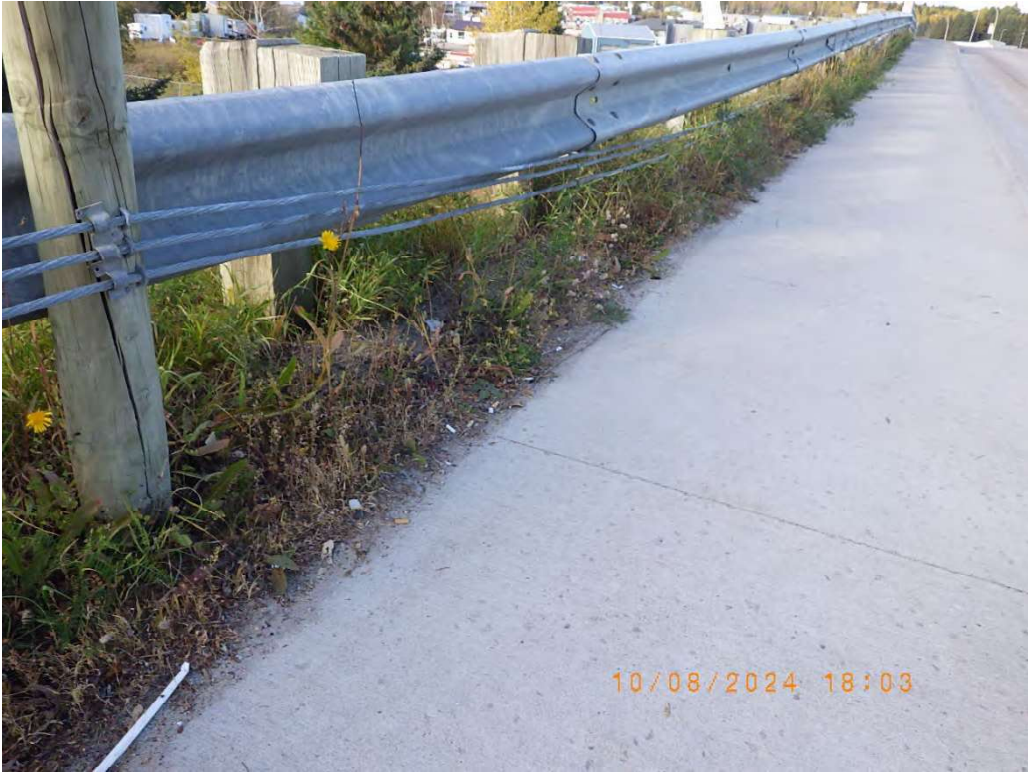
Wire rope cables are loose at the approach railing system.

Photo 40: Loose cables at south approach.

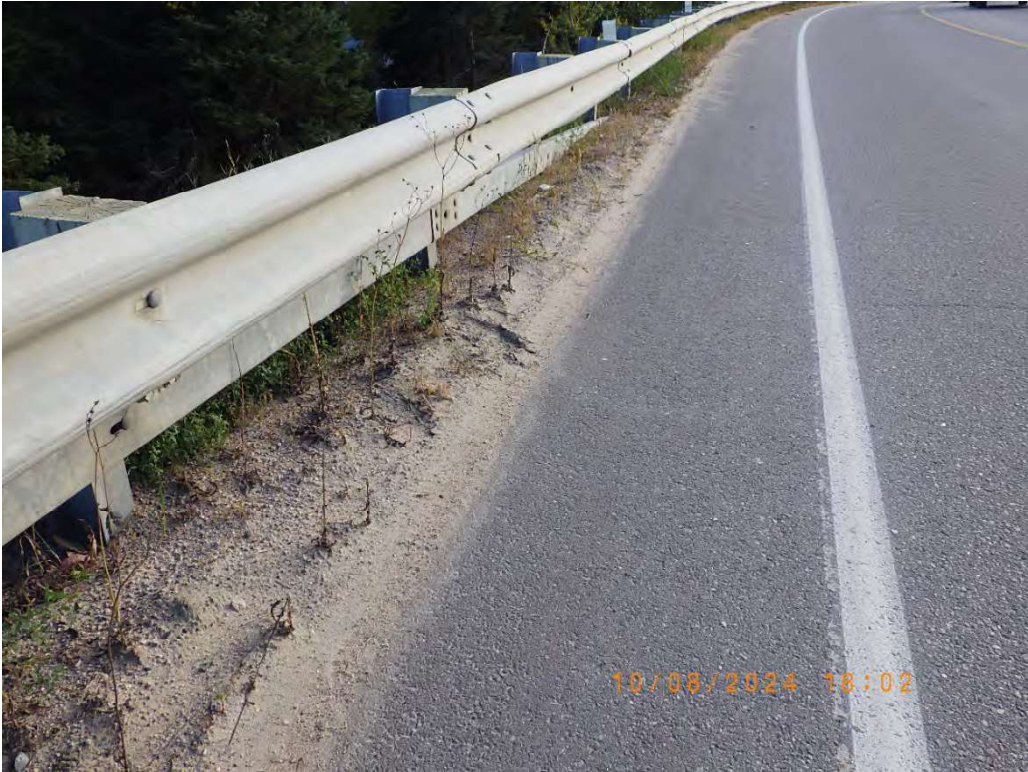
Gravel has built-up in front of steel beam guide rail at south approach to bridge.

Photo 41: Gravel accumulation in front of guide rail at east side of south approach.

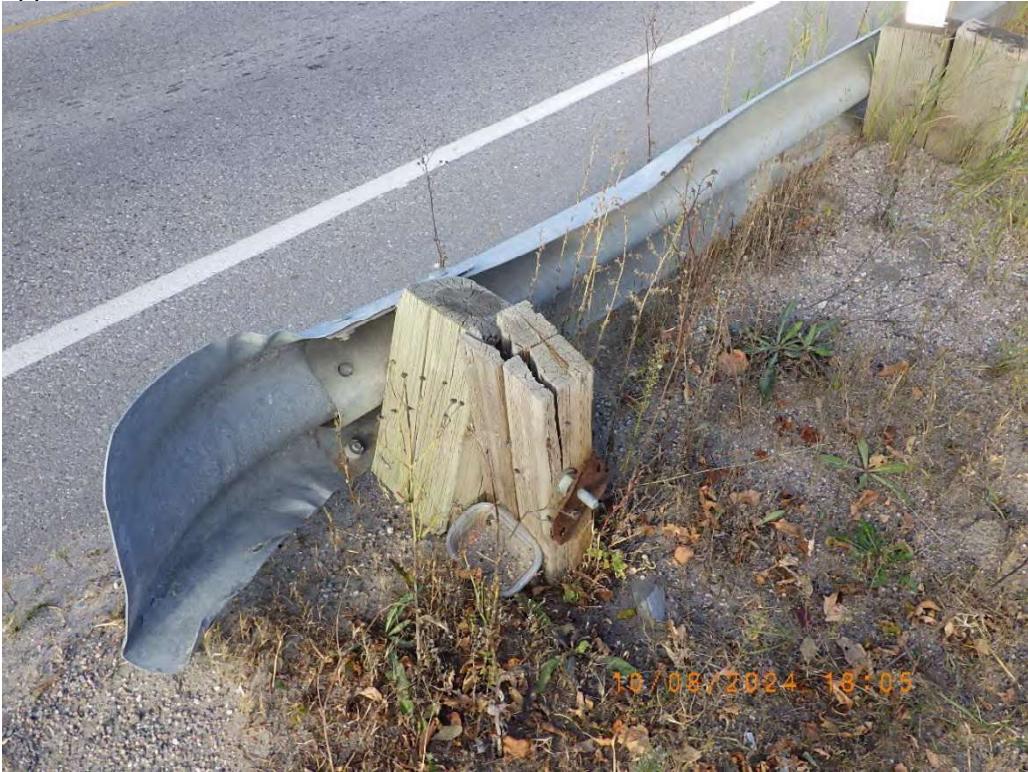
Rotated offset timbers were observed at southwest corner of site.

Photo 42: Rotated offset timber at southeast corner of site (typ.).
