Duke Street Bridge over Wabigoon River

**For The
City of Dryden**

Ref. No. JML2024090

December 2024

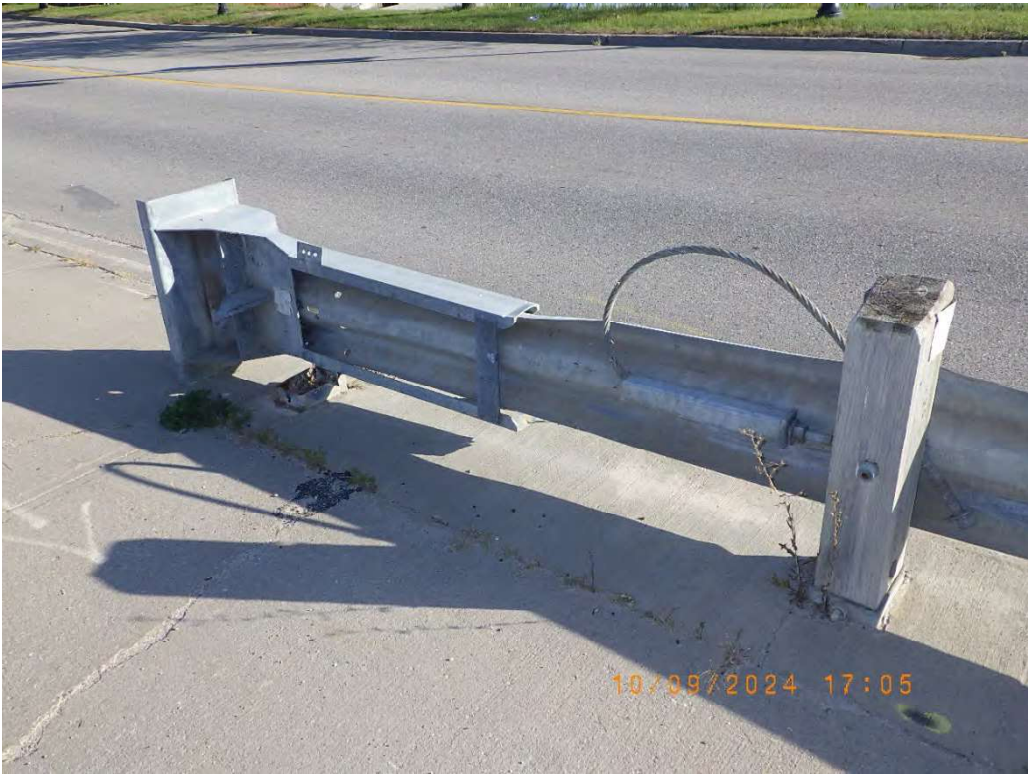
The guide rail end termination is loose and broken off at the posts at the southeast, southwest and northeast corners of the site.

Photo 17: Broken end post (typ. 3 locations).

- Replace termination posts at ends of steel beam guide rails at three corners of the site.
- Replace light bulbs within railing.

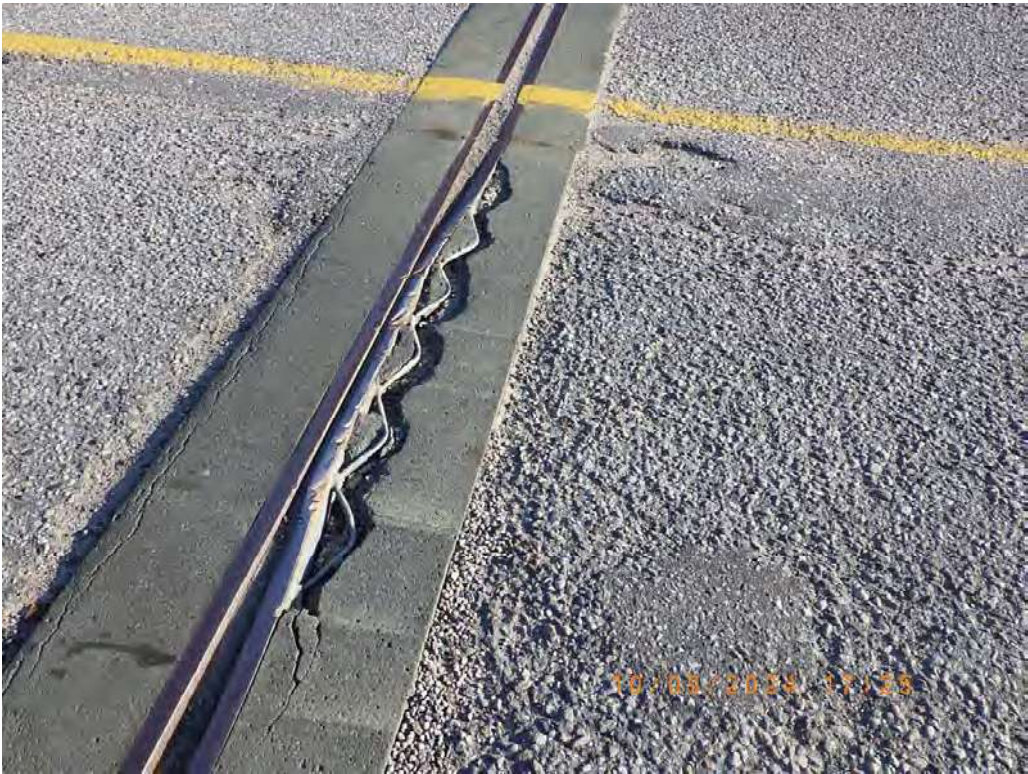
Gravel has accumulated in the expansion joints.

Although the deck expansion joint seals could not be directly inspected, the severe spalling observed at the top of the ballast walls indicates water has leaked through the seals onto the ballast walls, increasing the rate of deterioration. Therefore, we recommend the expansion joint seals be replaced.

Photo 18: Deteriorated concrete at end dams, corroded armoring, broken expansion joint, and gravel accumulation above seal at expansion joint (typ.).

- Replace the expansion joints seals, armouring and end dams.
- Replace asphalt and waterproofing system.
- Provide deck drains.
- Remove gravel from the deck joints.

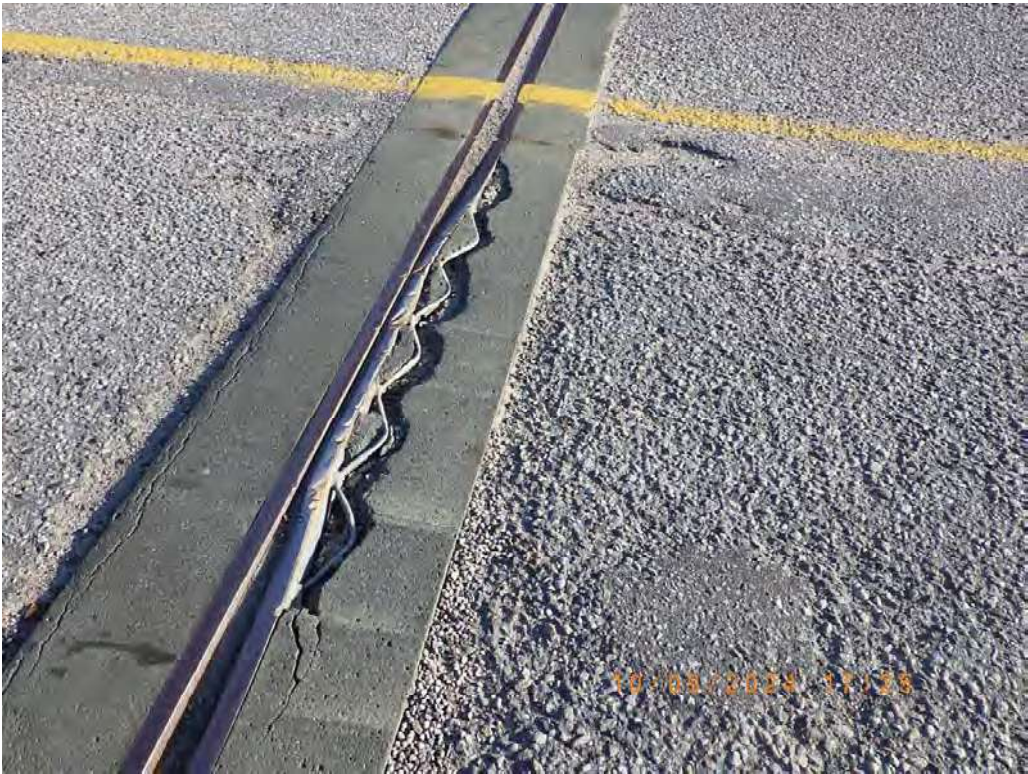
The asphalt aggregates are exposed on the surface over the entire deck.

Photo 19: Abrasion damage to asphalt on deck.

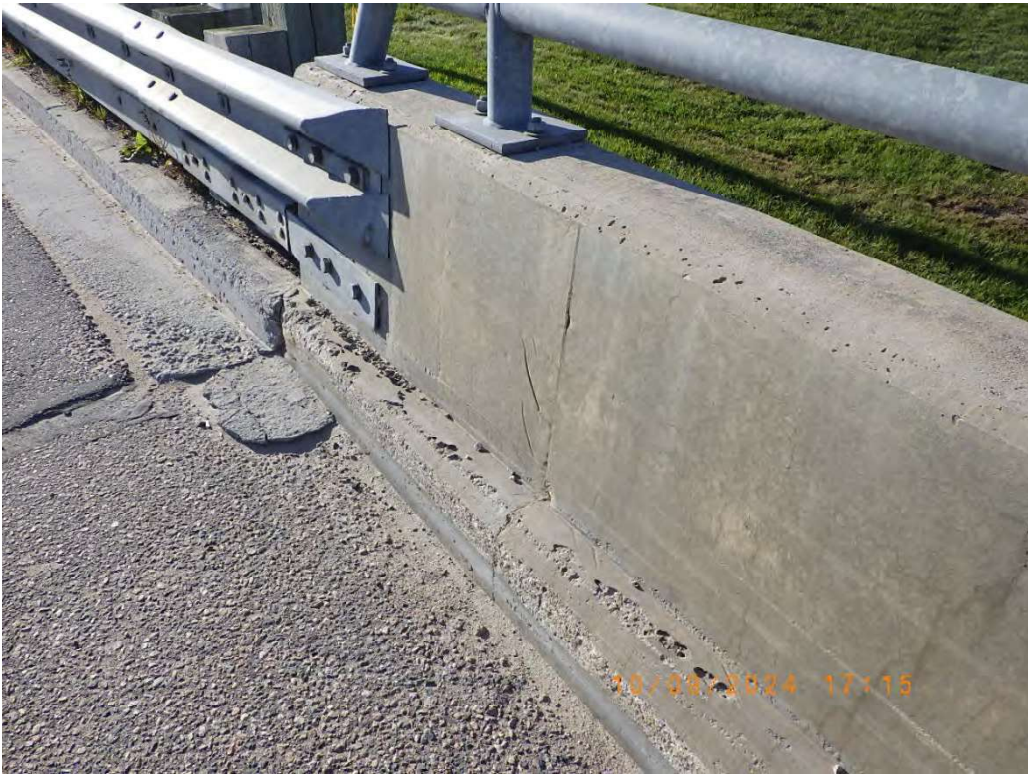
The asphalt is worn in front of the base of the concrete barriers.

Photo 20: Abrasion damage to barriers and asphalt along side of deck (typ.).

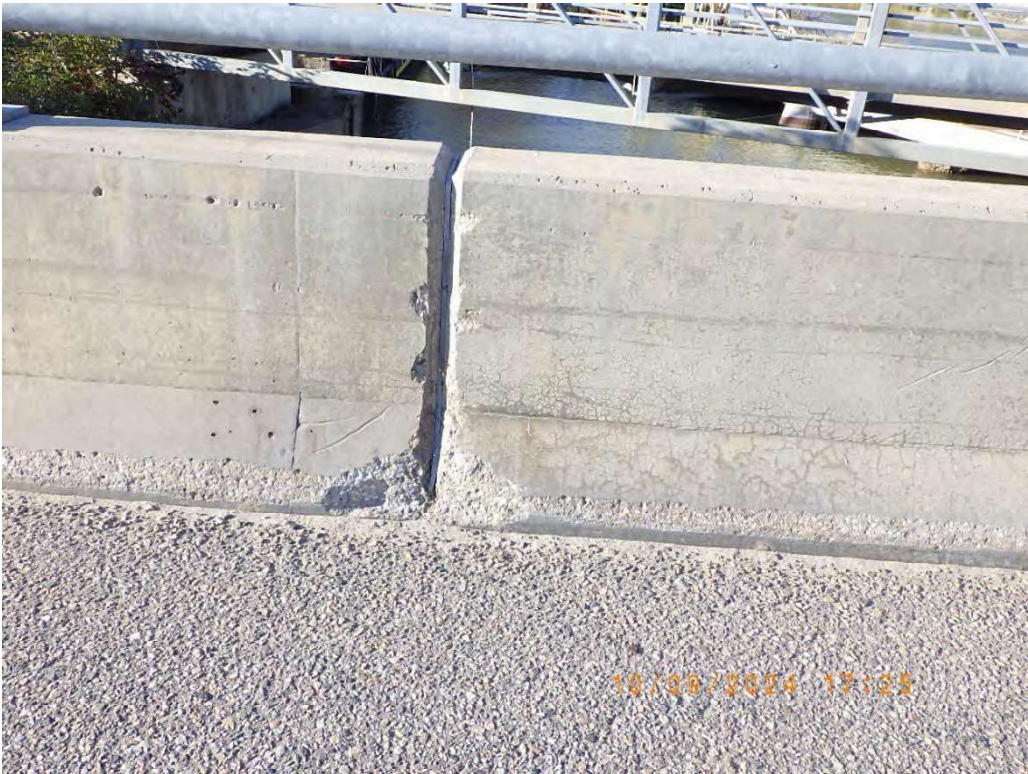
Spalling was observed at the base of the barriers at the barrier joints.

The sealant between the barriers has failed at a few locations.

Photo 21: Spalled concrete and missing sealant at barrier joint (typ.).

Repair spalled concrete and seal joints.

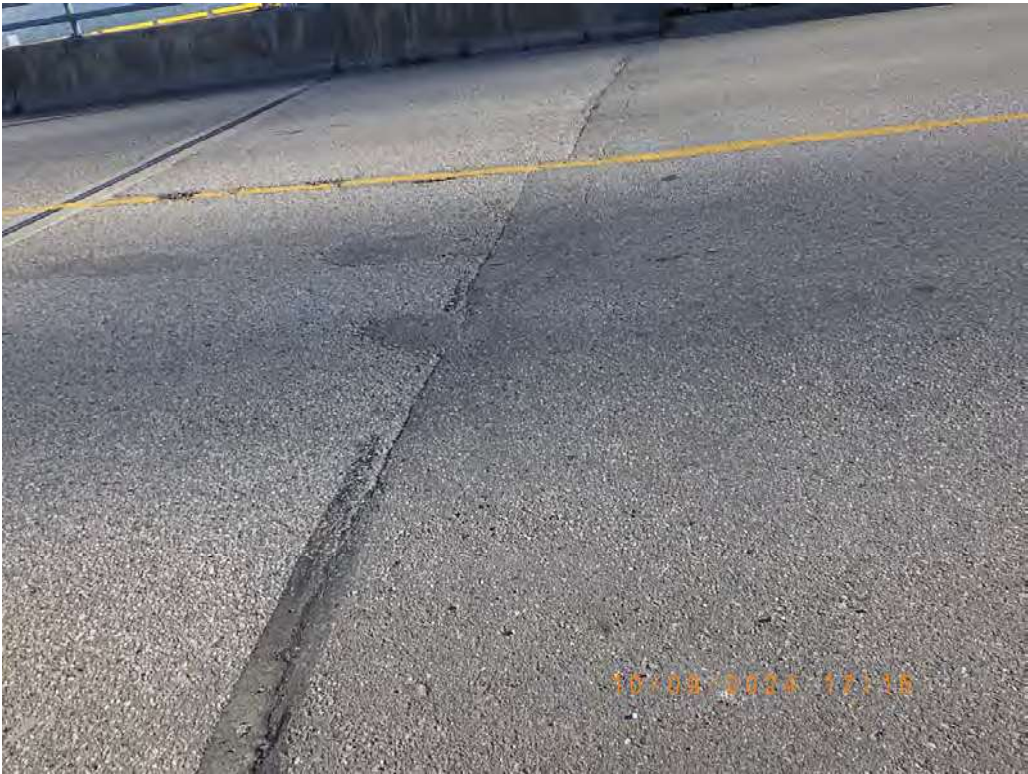
Asphalt sealant is missing at the approach slab joints.

Photo 22: Poor sealant and asphalt along east approach slab joint (typ.).

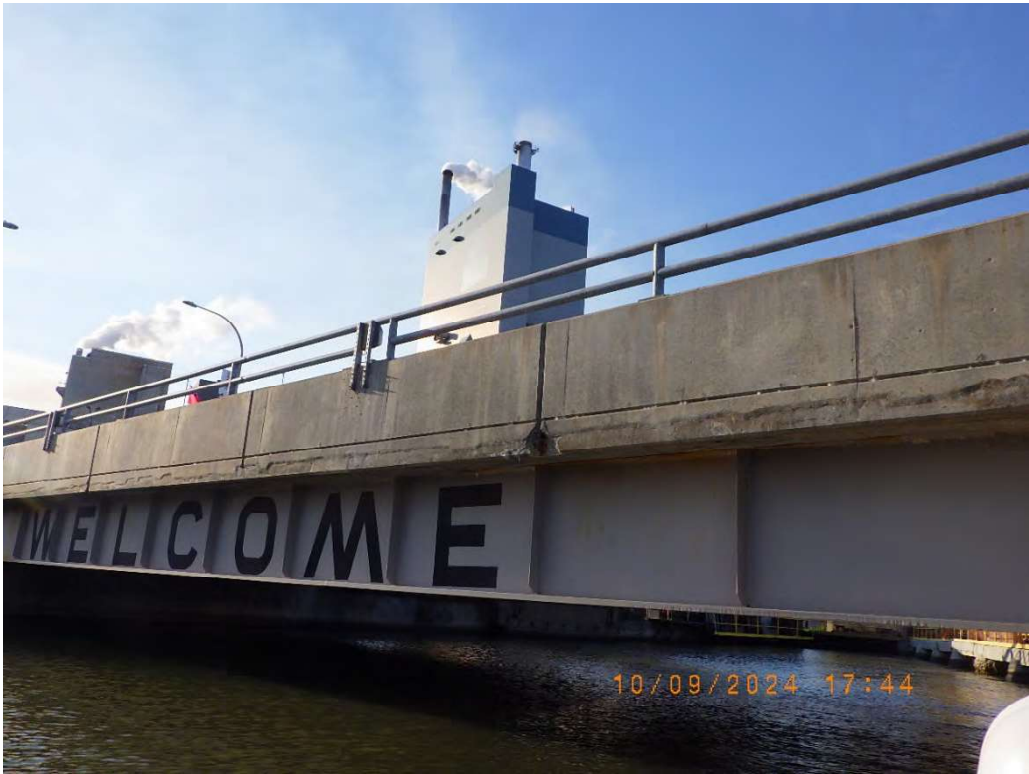
Spalling with efflorescence was observed at the south exterior face of the deck at the barrier joints.

Photo 23: Spall at south face of deck.

Repair spalls.

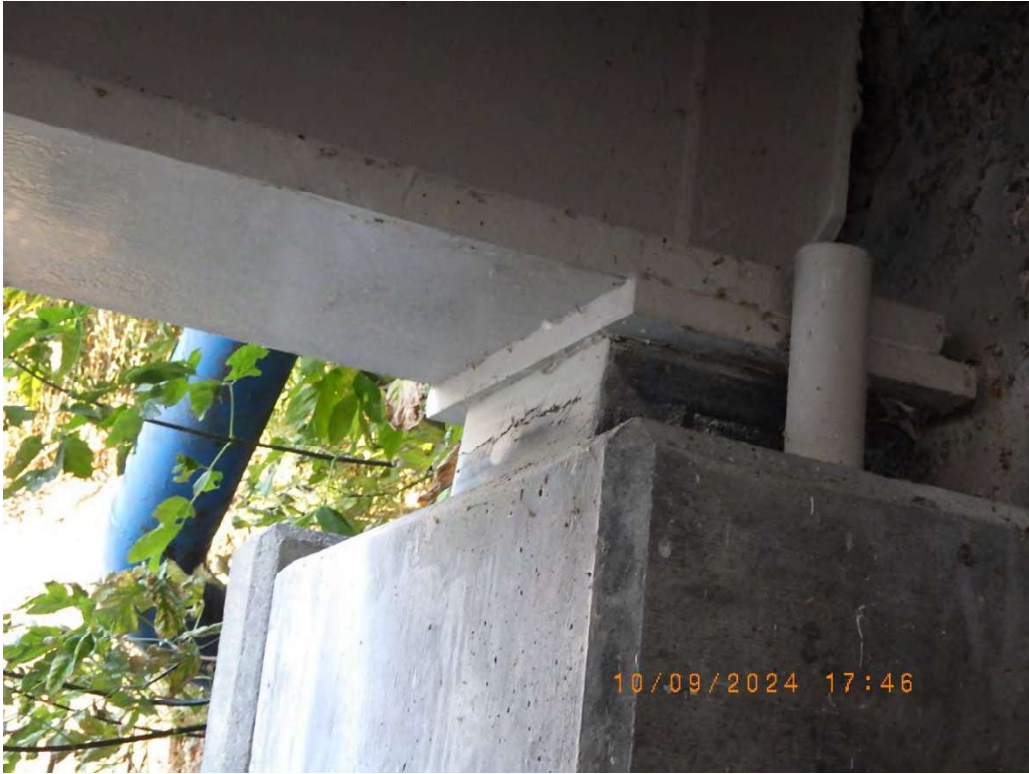
A few of the bearings contain horizontal edge cracks.

Photo 24: Bearing with horizontal cracks (typ.).

Element Group:	Abutments			Length:	
Element Name:	Bearings			Width:	
Location:	East and West abutment			Height:	
Material:	Other			Count:	5 each end
Element Type:	Elastomeric pad			Total Quantity:	10
Environment:	Benign / <u>Moderate</u> / Severe			Limited Inspection <input type="checkbox"/>	
Protection System:					Perform. Deficiencies
Condition Data:	Units m ² / m / <u>each</u> / % / all	Exc.	Good	Fair	Poor
				10	
Comments: Bearings are cracked.					
Recommended Work:			<input type="checkbox"/> Rehab <input checked="" type="checkbox"/> Replace	Maintenance Needs: 00	
			<input checked="" type="checkbox"/> 1-5 years <input type="checkbox"/> 6-10 years	<input type="checkbox"/> Urgent <input type="checkbox"/> 1 year <input type="checkbox"/> 2 year	
Replace bearings..

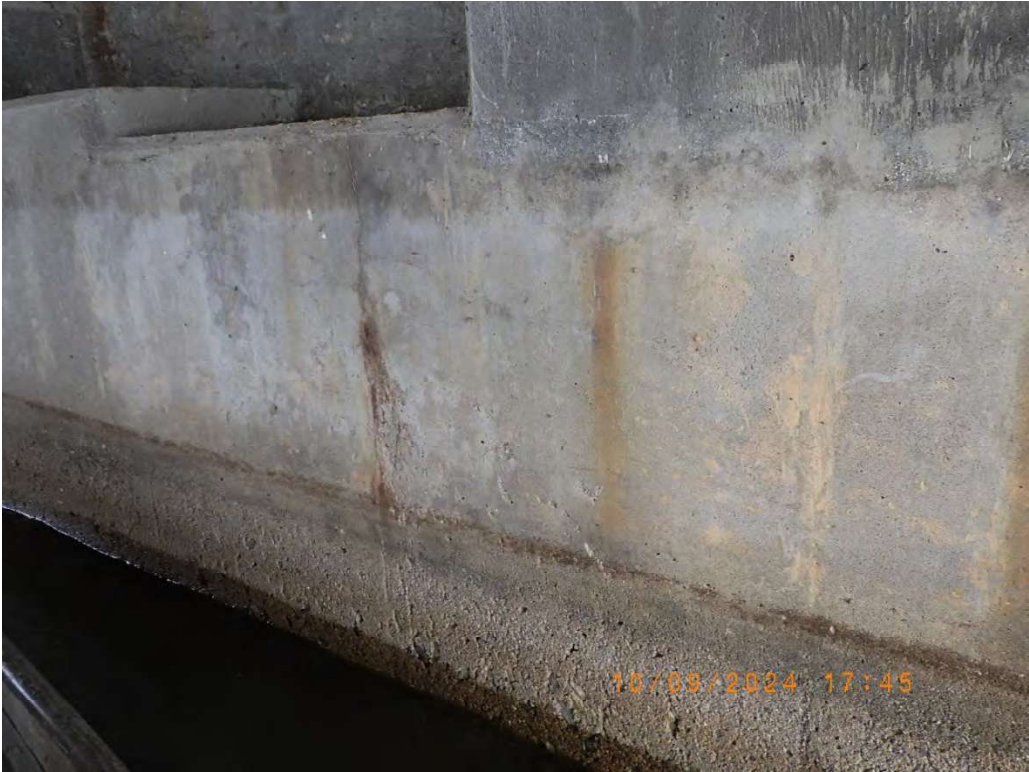
Three full height medium cracks were observed at the east abutment. Delamination and gravel/disintegrated concrete accumulation was observed at the west abutment.

Photo 25: Narrow vertical crack at east abutment.

Repair delaminated concrete. Inject cracks with epoxy.			Remove gravel.

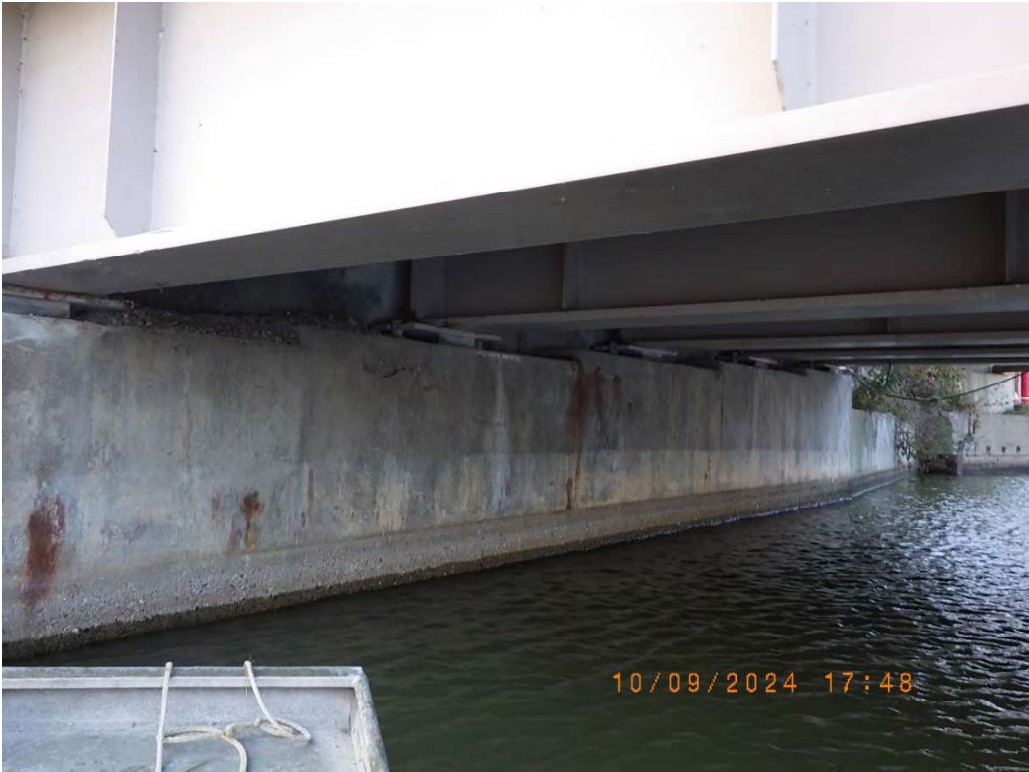
Photo 26: Delaminated concrete at west abutment.

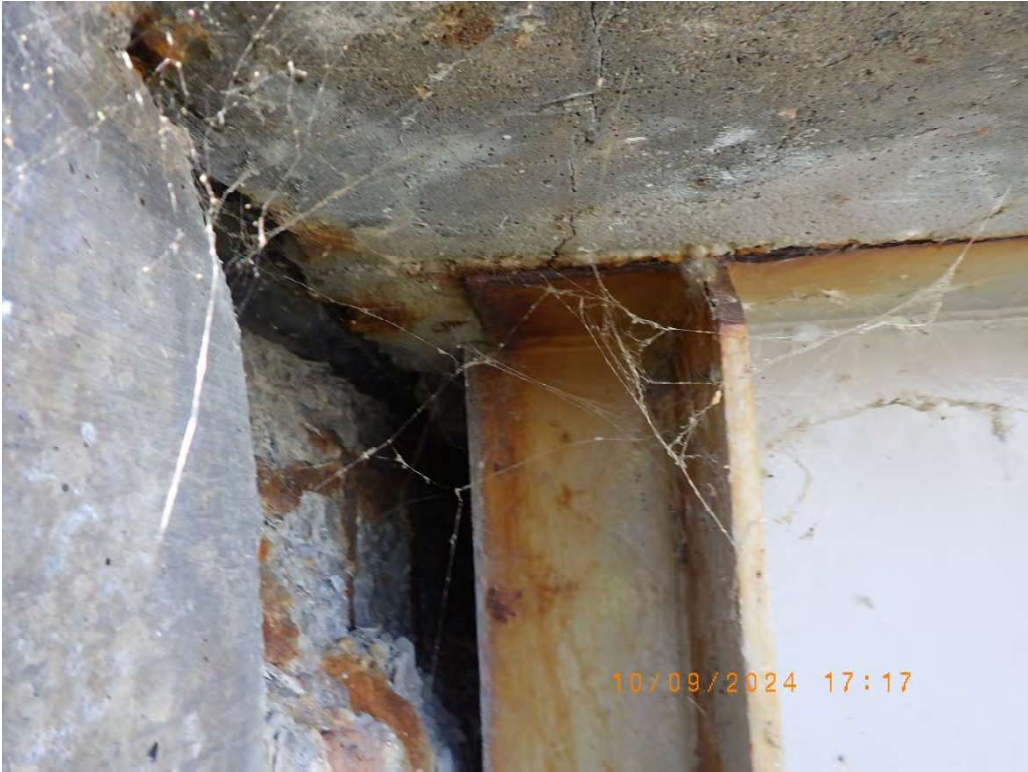
Severe spalling, delamination, and concrete disintegration was observed along the top of both ballast walls.

Photo 27: Spalled ballast wall at southwest corner of bridge (typ.).

Element Group:	Abutments			Length:		
Element Name:	Ballast Walls			Width:	11.0 m	
Location:	East and west abutments			Height:	2.0 m	
Material:	Cast-in-place concrete			Count:	2	
Element Type:				Total Quantity:	44.0 sq m	
Environment:	Benign / Moderate / <u>Severe</u>			Limited Inspection <input type="checkbox"/>		
Protection System:	None					Perform. Deficiencies
Condition	Units	Exc.	Good	Fair	Poor	
Data:	<u>m²</u> / m / each / % / all		20	12	12	00
Comments: Severe spalling/concrete disintegration along top of both ballast walls and at south corner of west wall. Delamination at both walls.						
Recommended Work:			<input checked="" type="checkbox"/> Rehab <input type="checkbox"/> Replace	Maintenance Needs:		00
			<input checked="" type="checkbox"/> 1-5 years <input type="checkbox"/> 6-10 years	<input type="checkbox"/> Urgent <input type="checkbox"/> 1 year <input type="checkbox"/> 2 year		
Repair concrete.

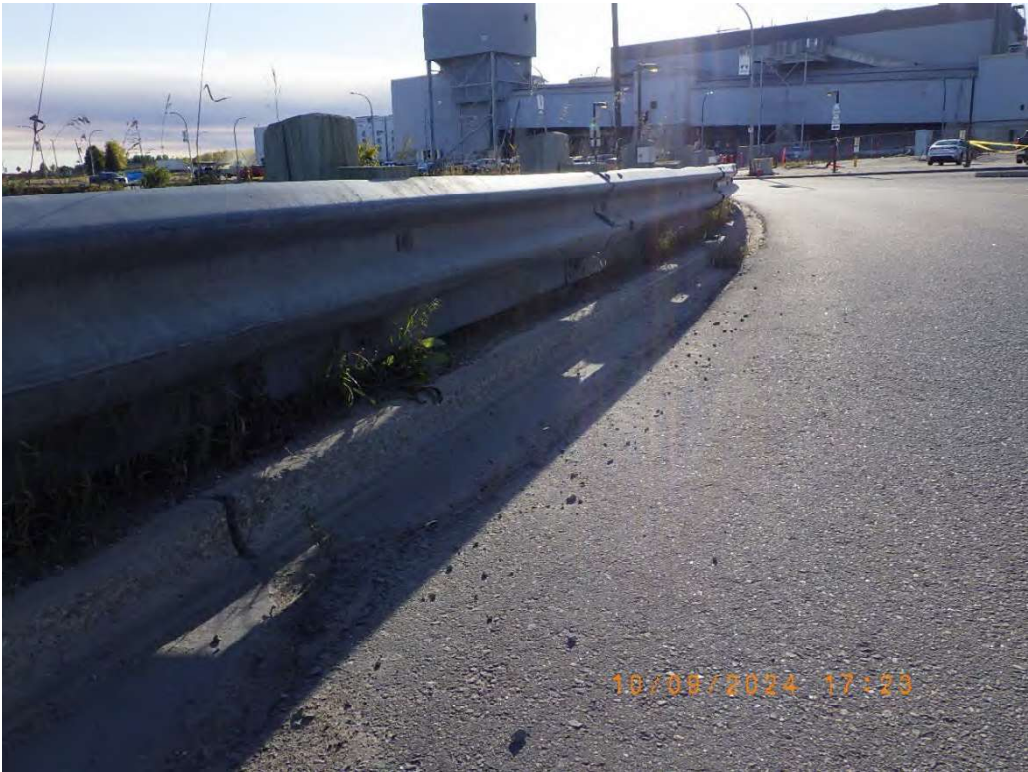
and abrasion damage was observed at the curb and gutters at the southeast and southwest corners of the site.

Photo 28: Abrasion damage to curb and gutter at southwest corner of site.

Element Group:	Approaches			Length:	
Element Name:	Curb/Gutters			Width:	
Location:	East and West approaches			Height:	
Material:	Cast-in-place concrete			Count:	6.0 m per corner
Element Type:				Total Quantity:	24.0 m
Environment:	Benign / Moderate Severe			Limited Inspection <input type="checkbox"/>	
Protection System:	None				Perform. Deficiencies
Condition Data:	Units m ² (m) / each / % / all	Exc.	Good	Fair	
<p>Comments: Wide crack, impact and abrasion damage at base at southeast and southwest corners of the site.</p>					
Recommended Work:			<input type="checkbox"/> Rehab <input type="checkbox"/> Replace <input type="checkbox"/> 1-5 years <input type="checkbox"/> 6-10 years	Maintenance Needs:	18
				<input type="checkbox"/> Urgent <input type="checkbox"/> 1 year <input type="checkbox"/> 2 year	
				Repair damaged sections.

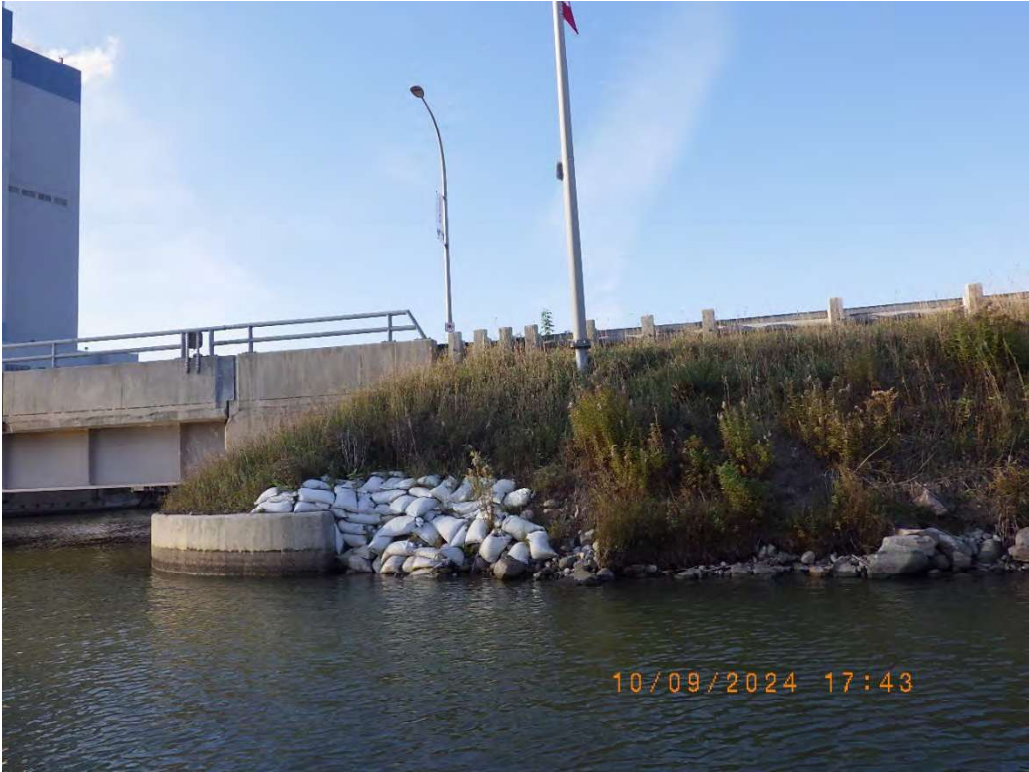
Sandbags have remained since 2022 to stabilize the base of the southeast and southwest embankments.

Photo 29: Sandbags at base of southeast embankment.
