City of Dryden Dryden Signature Trail System Improvements Feasibility Study

Final Report, March 2022

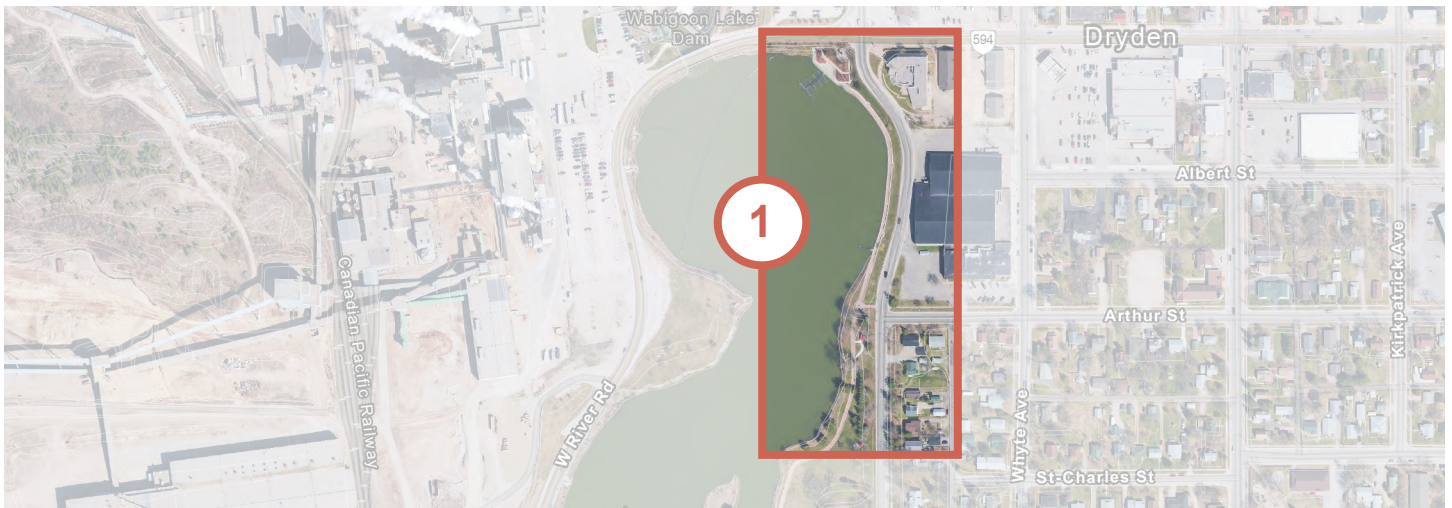
Segment 1: North End of Trail

- Areas of trail uneven.
- Precast concrete unit pavers shifting in spots.
- Concrete retaining wall is slumping.
- Park includes a seasonal washroom.
- Two large cottonwood trees serve as 'pillars' to the next portion of the trail.
- Benches and waste receptacles along this section of trail at approximately 60m intervals.

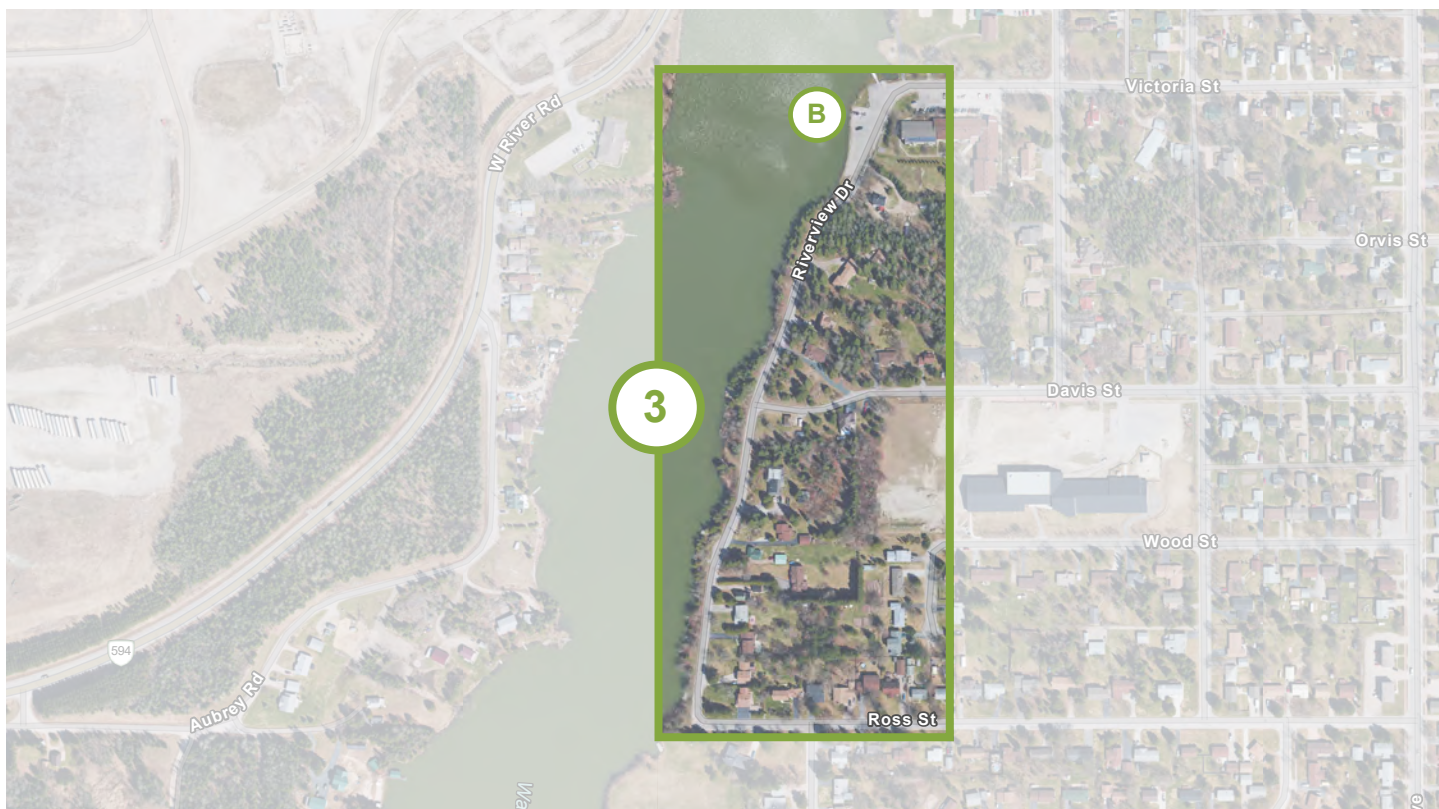
Segment 3: Riverview Dr. from Victoria St. to Ross St.

- Skene Boat Launch (B) marks the end of the dedicated trail along the shoreline and the trail now moves onto the undifferentiated pavement at the intersection of Davis St. and Riverview Dr. This creates pedestrian and traffic congestion with the boat launch, roadway and path all intersecting in the same area.

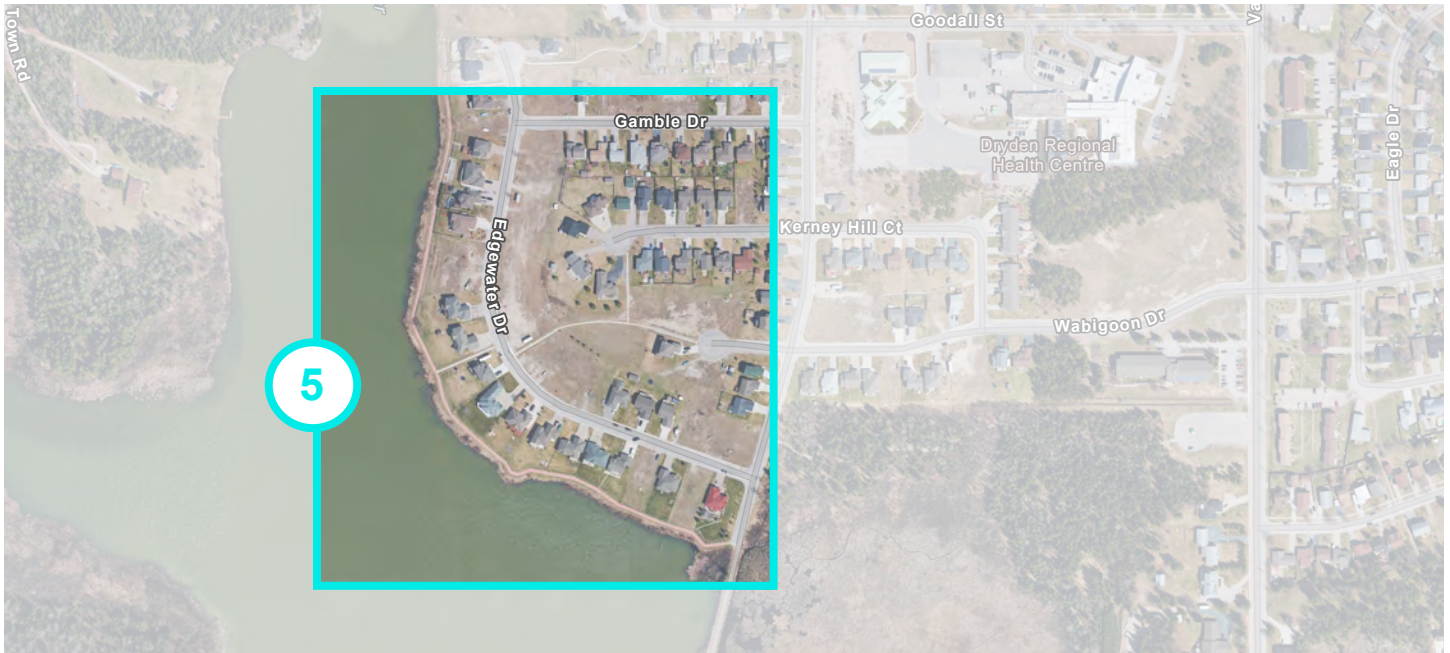
Segment 5: Edgewater Dr. to Yacht Club Rd.

- Precast concrete unit pavers along stretch of trail behind private residences - some uneven and low spot areas.
- Doggy bag amenities, concrete light poles spaced every \pm 30m.
- Scenic views of the Wabigoon River.
- Yacht Club Rd. is a gravel causeway through the Laura Howe Marsh to a forested area on the other side.

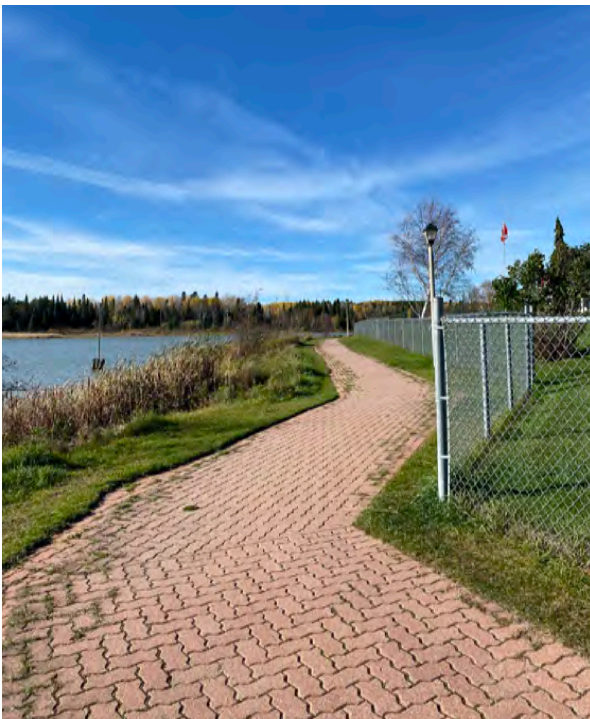
Photo 18: Unit paver trail behind houses

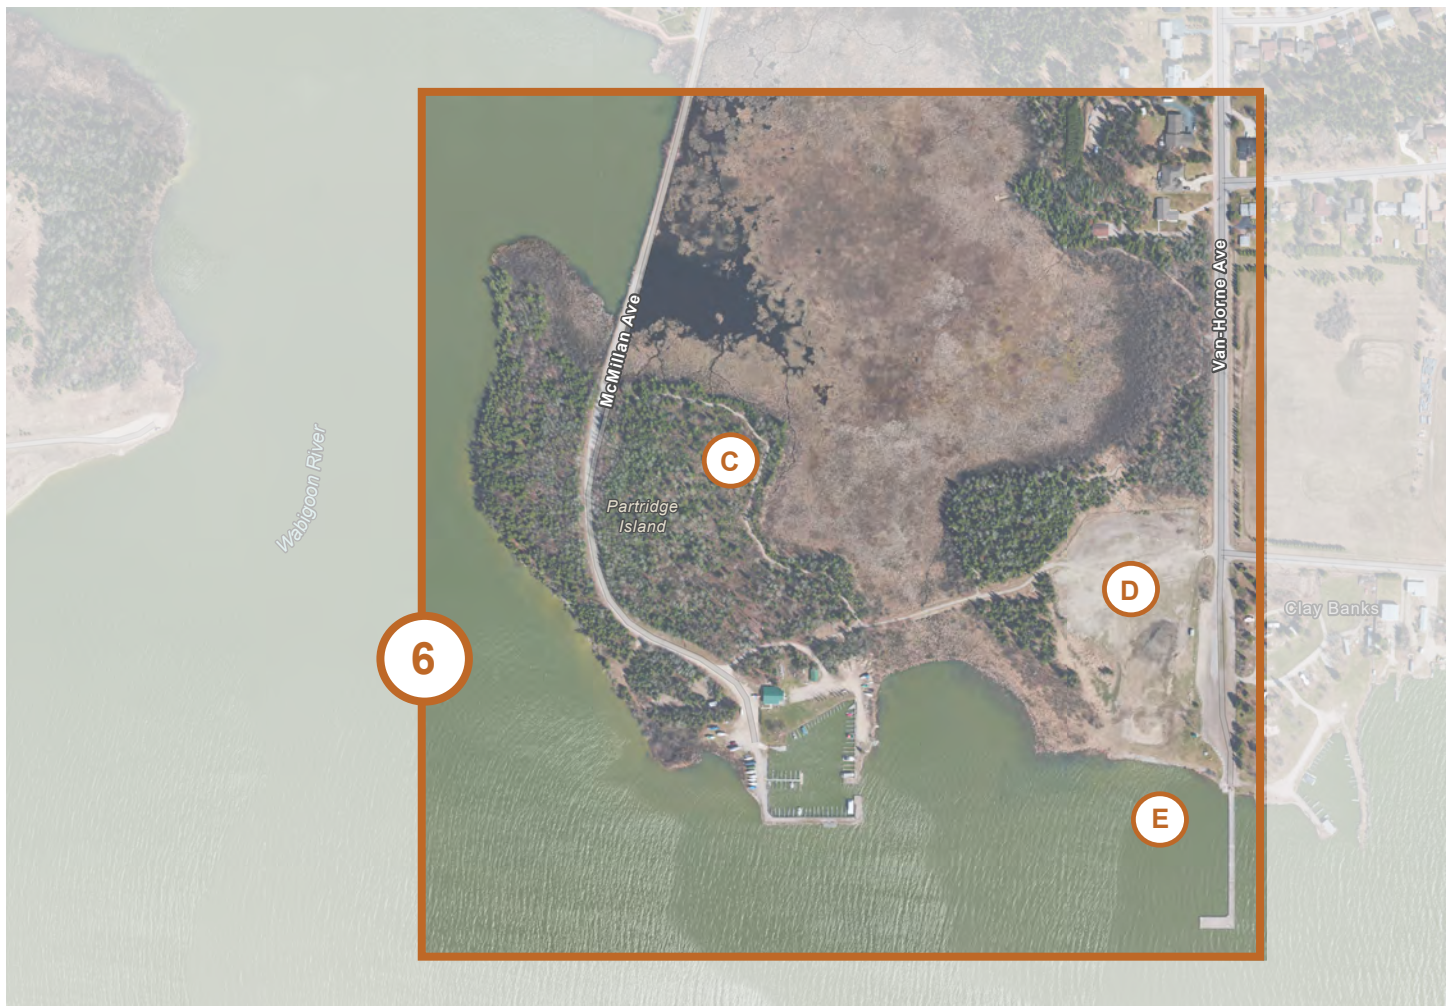
Segment 6: Laura Howe Marsh to Van Horne Landing

- This section of the trail runs along the gravel causeway (Yacht Club Rd.), through the forest to the south along a packed granular trail along the Laura Howe marsh (C), opens up to a large, open field (D) and terminates at the Van Horne Landing at the southern end of the trail (E).
- Poplar, birch, spruce forest.
- Trail opens up to large, empty field at Van Horne Landing - very windy, exposed site.
- Trail head signage is located at the southern entrance to the trail and has two large granite blocks placed as a deterrent for motorized vehicles.
- Trail head sign with map is in good condition.
- Parking lot that terminates at the water's edge does not have well defined edges - unclear where to park, navigate boat launch, pedestrian access, etc.
- City of Dryden owns part of the forest to the west of the large, open field.

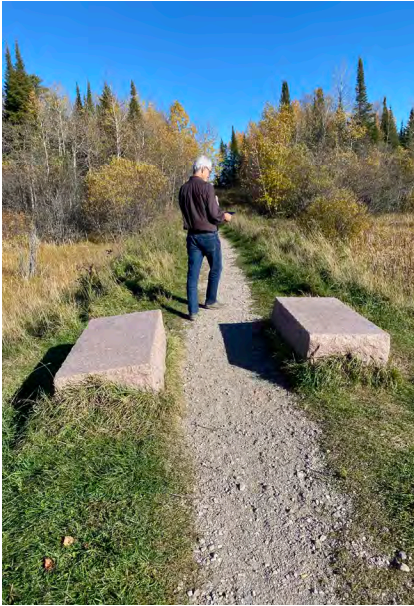
Photo 20: Granite quarry block vehicle deterrents

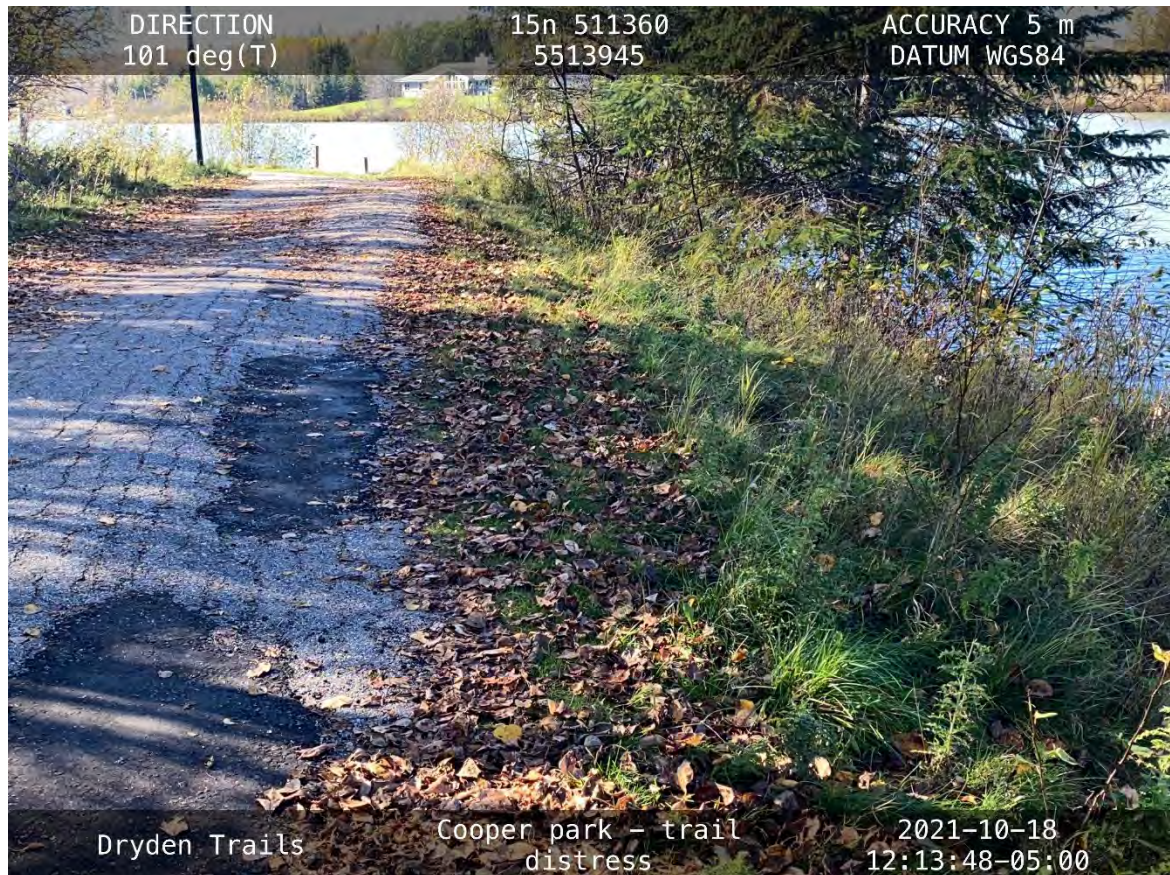
Photo 3 – Pathway pavement distress in Cooper's Park

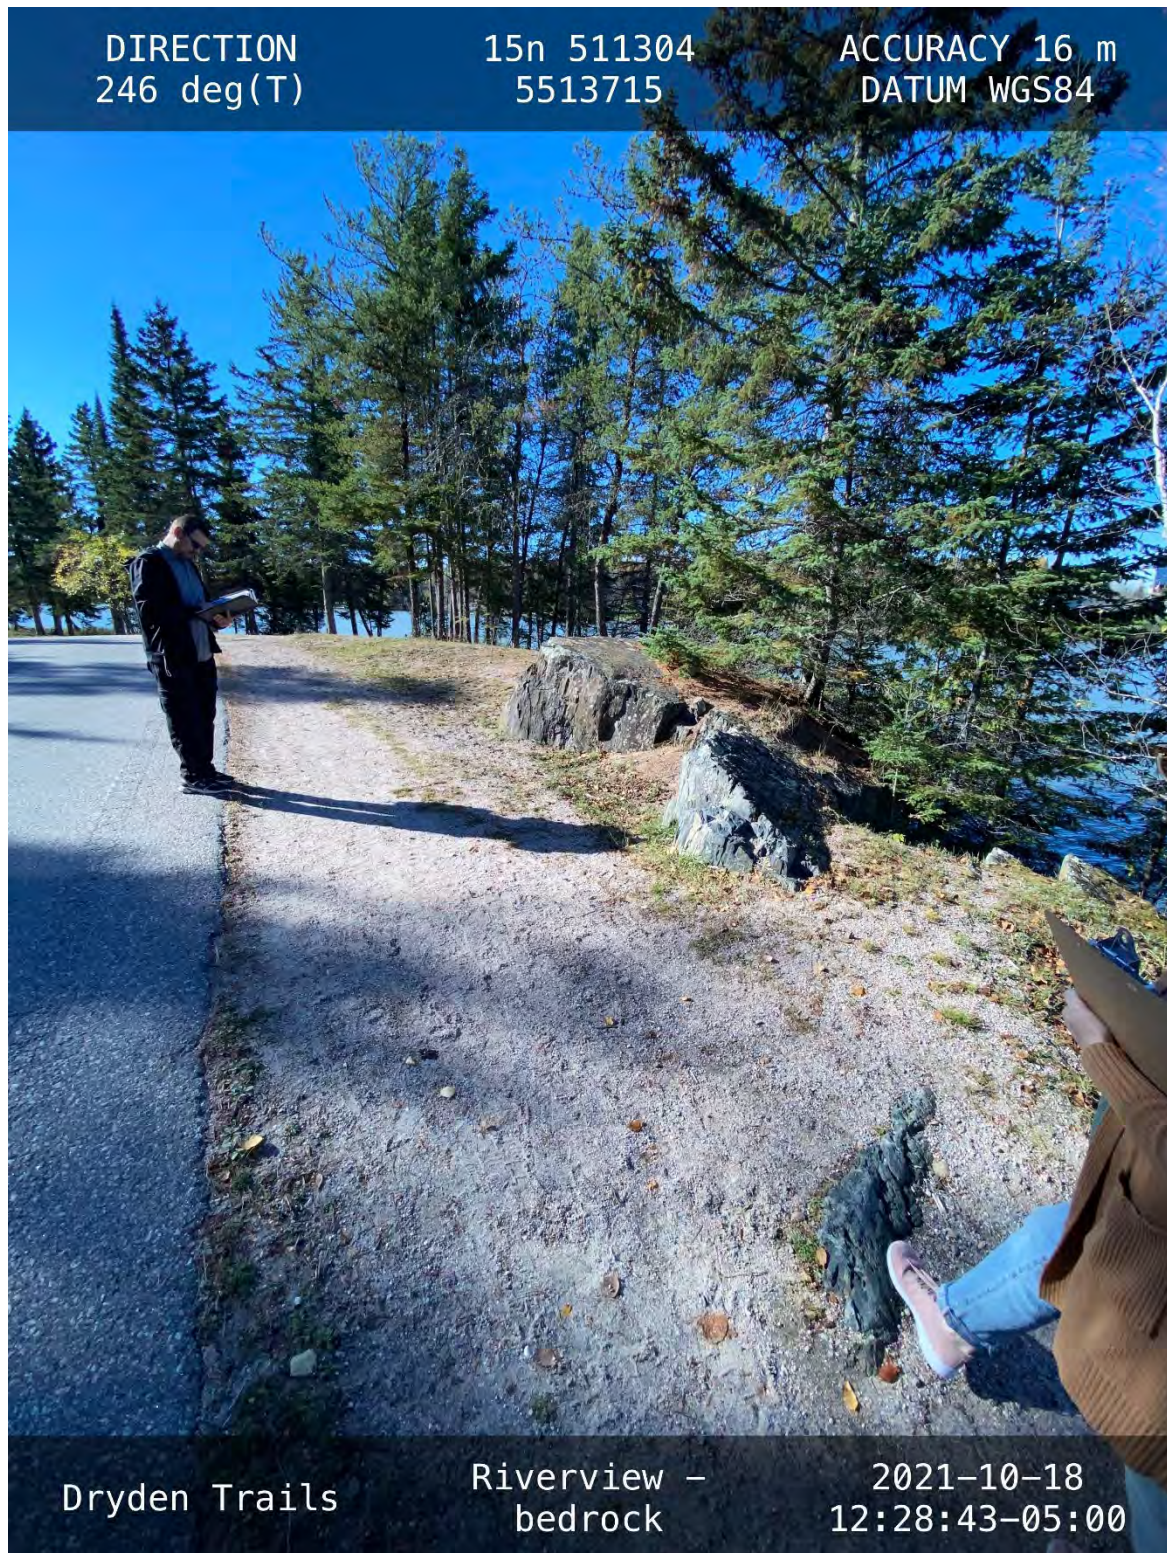
Photo 5 – Discontinuous trail in Section 3 (adjacent Riverview Drive)

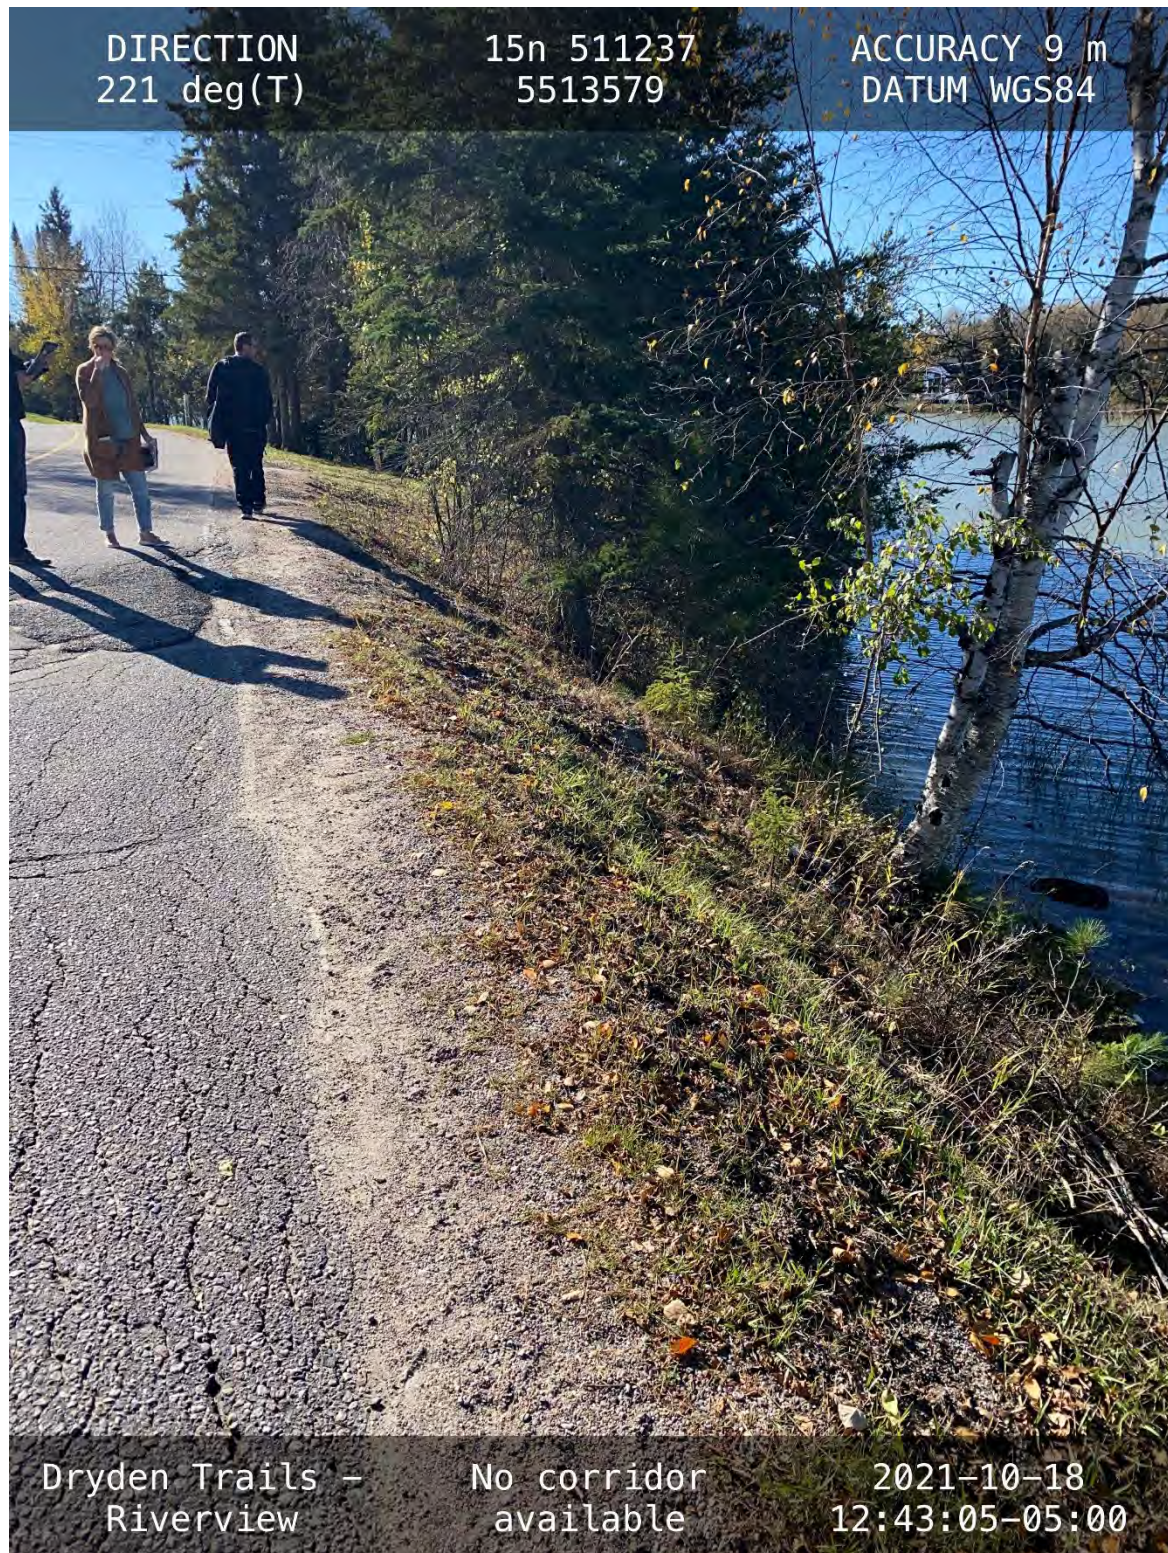
Photo 7 – Steep slopes in Section 3 (Riverview Drive)

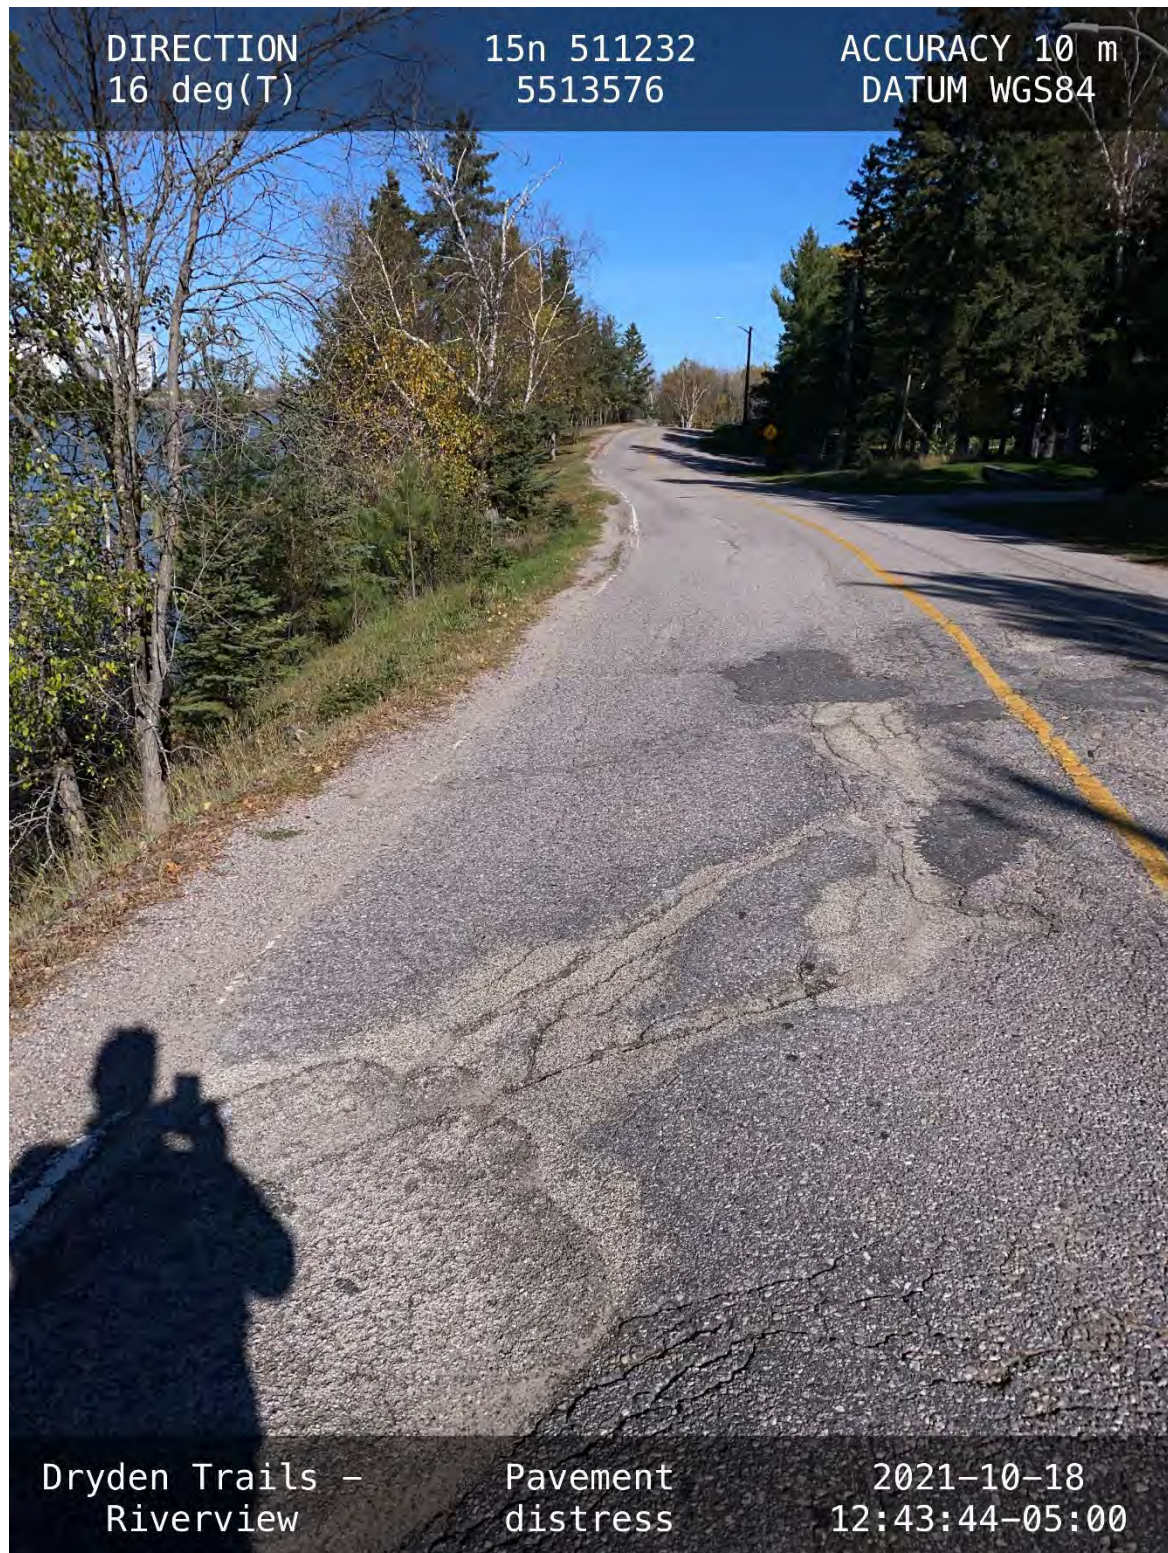
Photo 8 – Pavement distress due to slope creep movements in Section 3 (Riverview Drive)

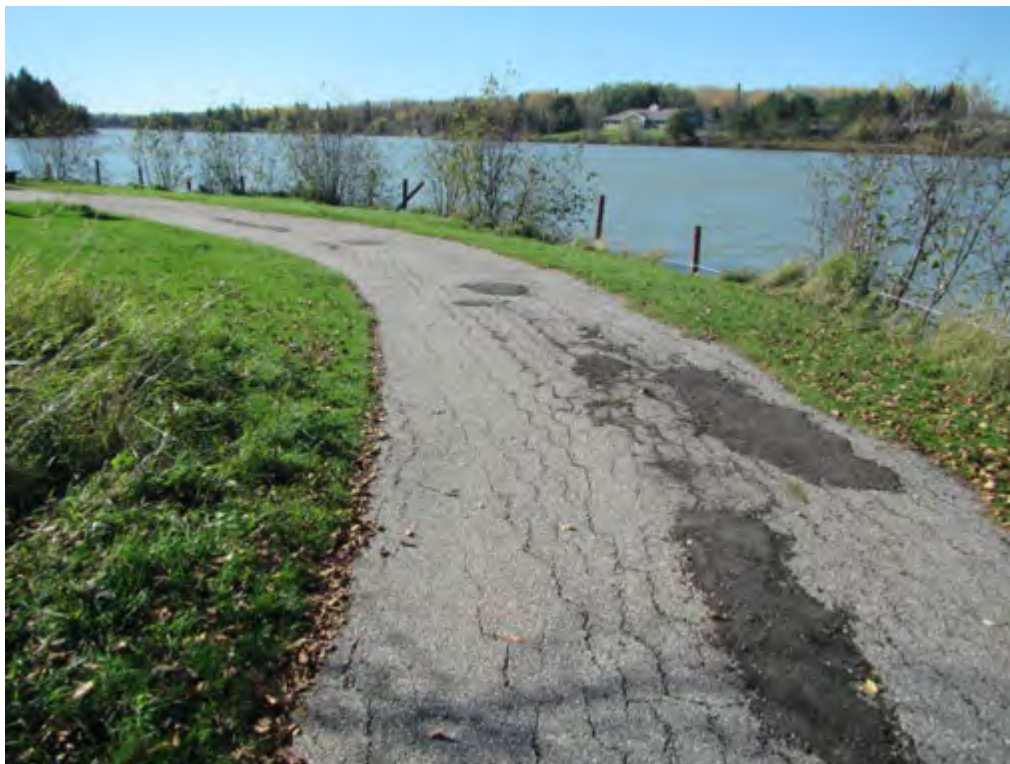
Photo 6: Patched Asphalt Trail Section just North of Skene Landing

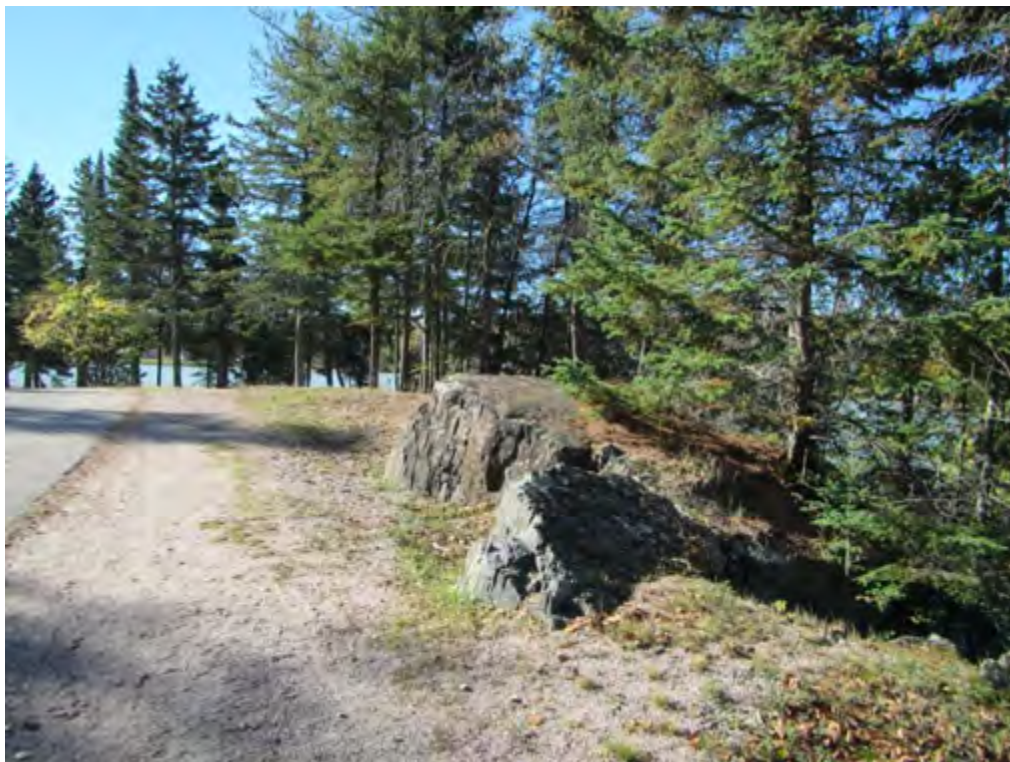
Photo 8: Trail ending along Riverview Drive
