Duke Street Bridge over CP Railway

City of Dryden

Ref. No. JML2024090

December 2024

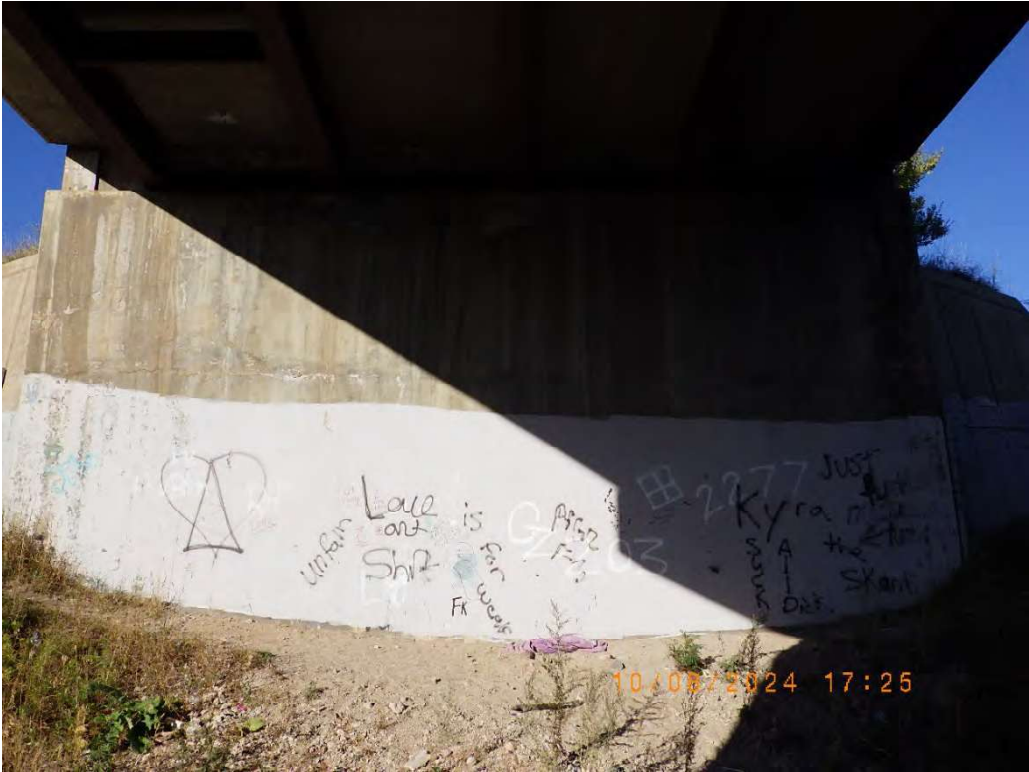
Photo 9: North abutment.

Two full height medium cracks were observed at the north and south abutments.

Three areas of delamination were observed at the north abutment. Delamination and two spalls were observed at the south abutment.

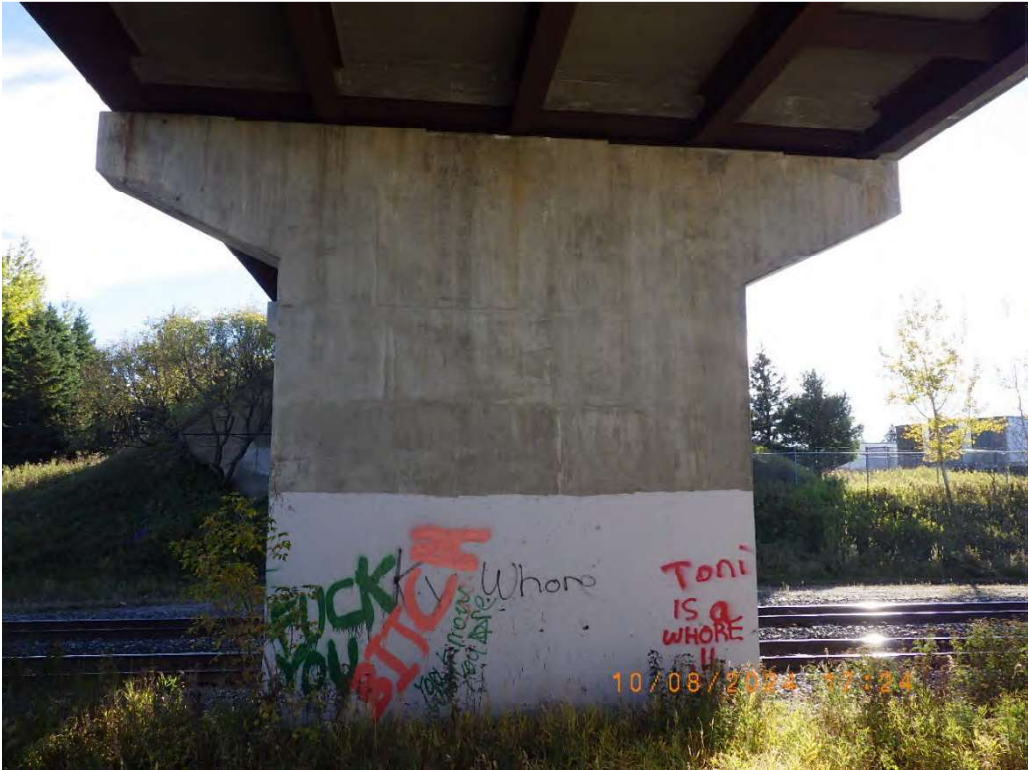
Photo 15: North face of north pier.

Delamination and one wide crack was observed at the south pier. A spall with exposed rebar, one area of delamination, and one wide crack was observed at the north pier.
