Duke Street Bridge over Wabigoon River

**For The
City of Dryden**

Ref. No. JML2024090

December 2024

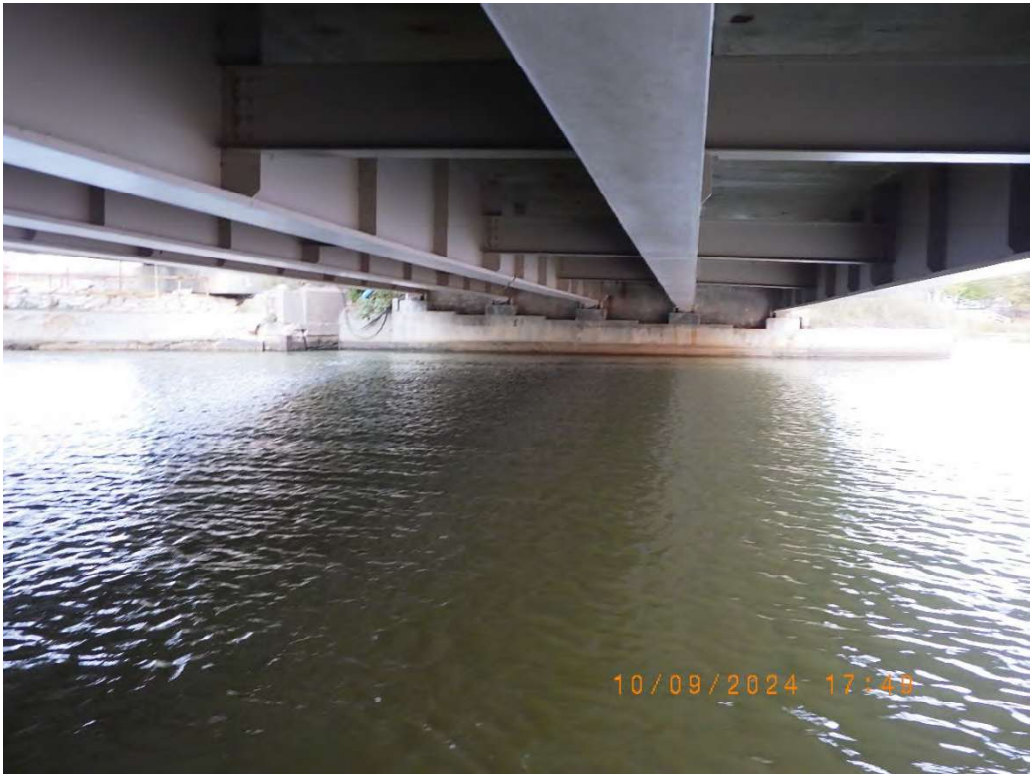
Photo 7: East abutment.

Three full height medium cracks were observed at the east abutment. Delamination and gravel/disintegrated concrete accumulation was observed at the west abutment.

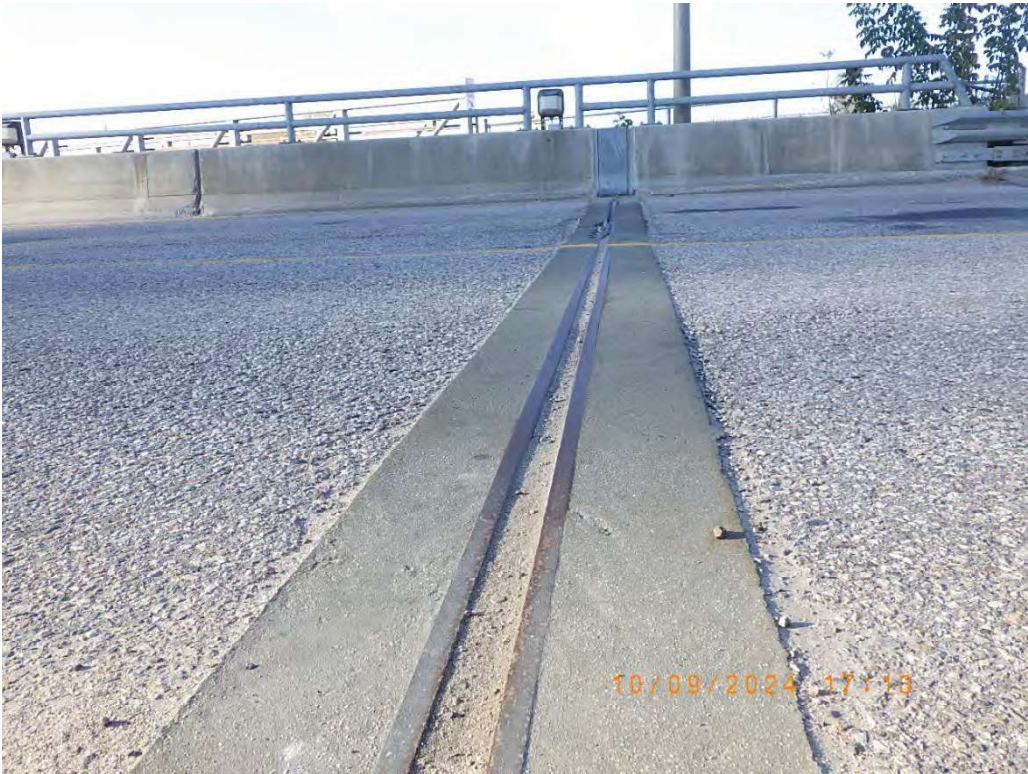
Photo 11: East expansion joint.

Gravel has accumulated in the expansion joints.

Although the deck expansion joint seals could not be directly inspected, the severe spalling observed at the top of the ballast walls indicates water has leaked through the seals onto the ballast walls, increasing the rate of deterioration. Therefore, we recommend the expansion joint seals be replaced.

- Replace the expansion joints seals, armouring and end dams.
- Replace asphalt and waterproofing system.
- Provide deck drains.
- Remove gravel from the deck joints.
