# DRYDEN

## City of Dryden Facilities Master Plan

(Final Report)

DECEMBER 2022

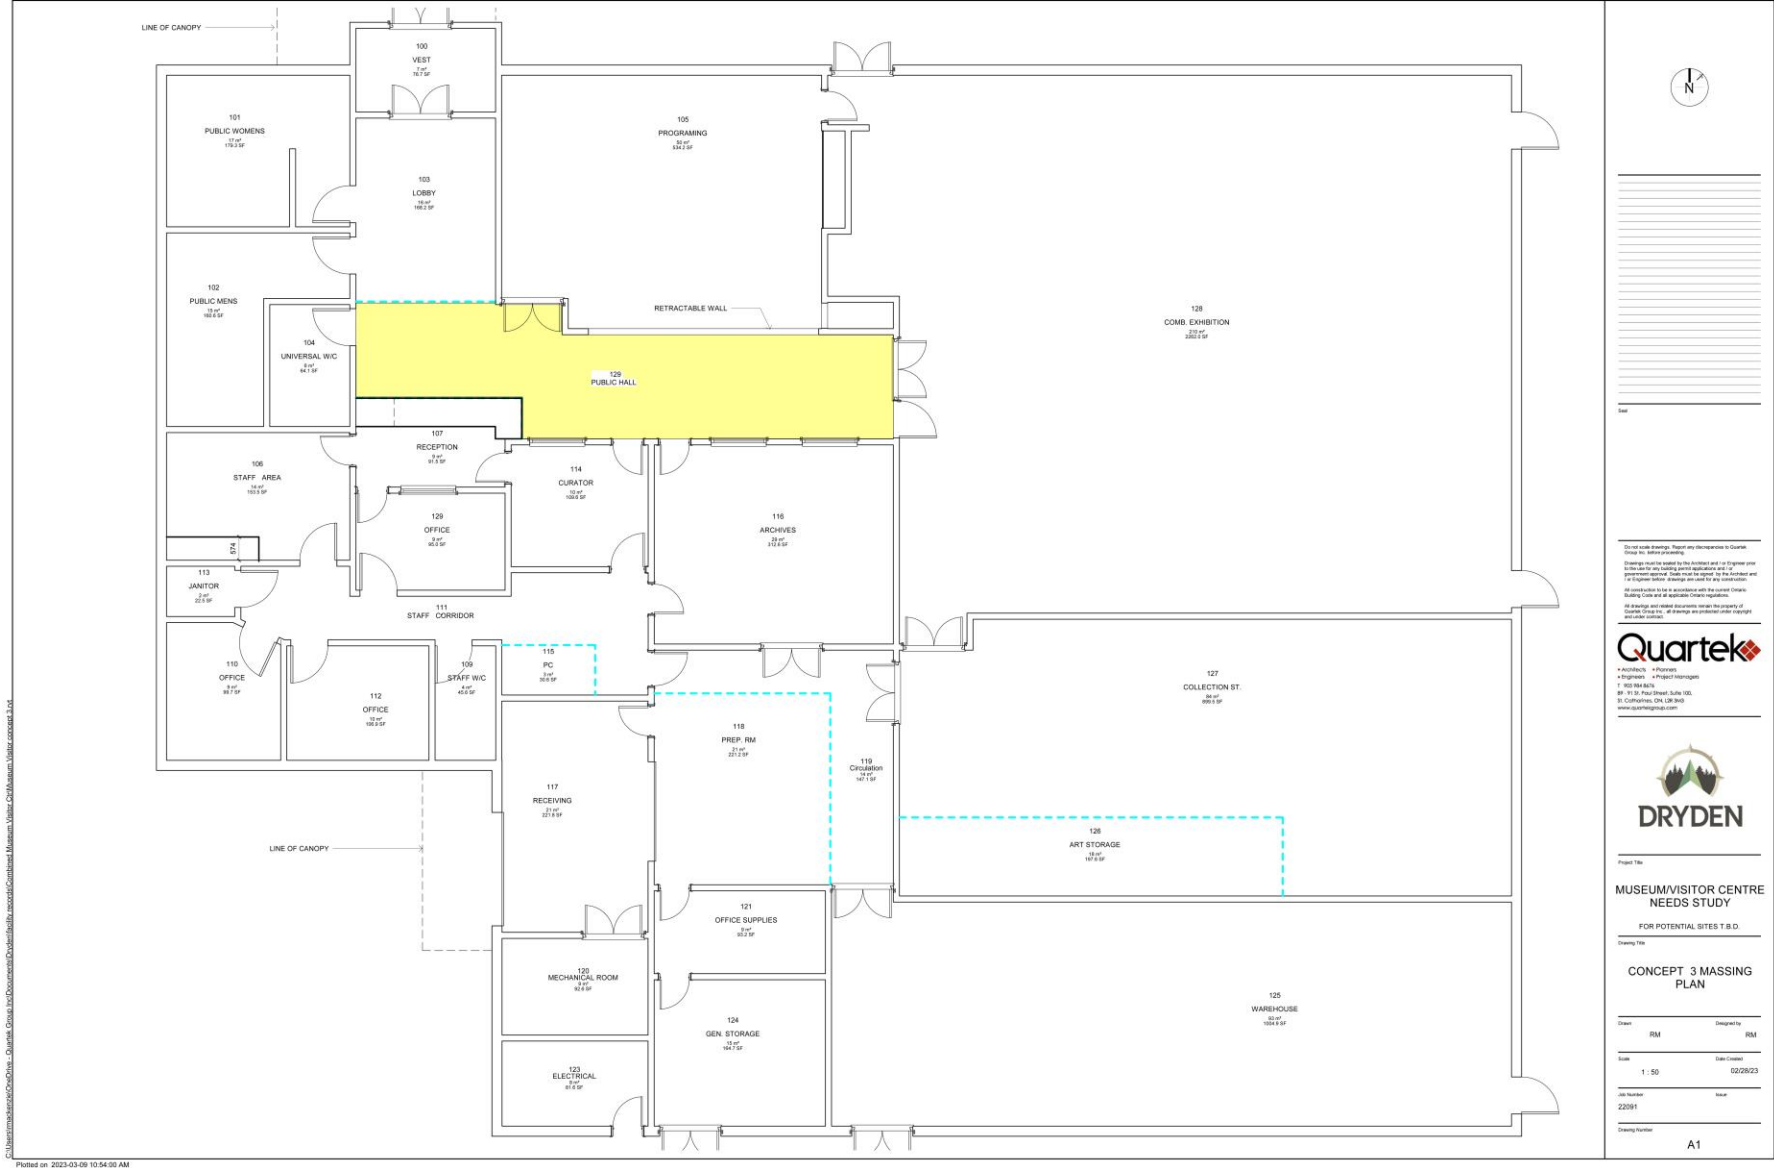
Figure 15. Museum/Visitor Centre: general massing plan for concept #1.

- an increased visibility of the front entrance from staff offices and areas
- an intuitively walkable space for museum visitors
- access to the public washrooms (as a Visitor Information Centre)
- positioning the programming room at the front of the building for easier access

The Project Team then presented the block massing plan to City staff members for their initial reviews and comments. The proposed design met the SOR objectives. That said, when the Project Team submitted the proposed design, it was understood that the design was preliminary and subject to change.

As shown in Figure 15, the Project Team prepared a high-level building layout of the Museum/Visitor Centre using 170 Government Street as the potential site. In this layout, the Project Team aimed to accommodate the following:
