City of Dryden Dryden Signature Trail System Improvements Feasibility Study

Final Report, March 2022

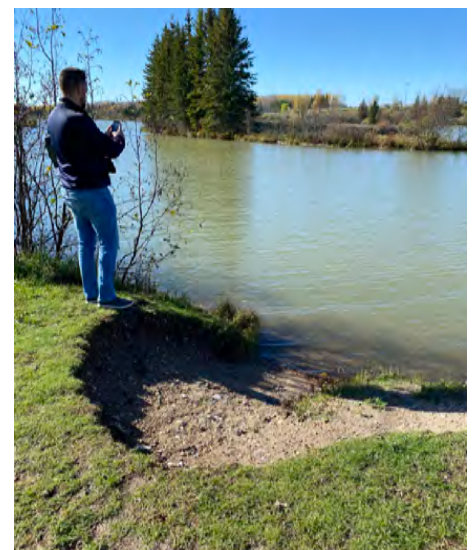
Photo 4: Shore erosion

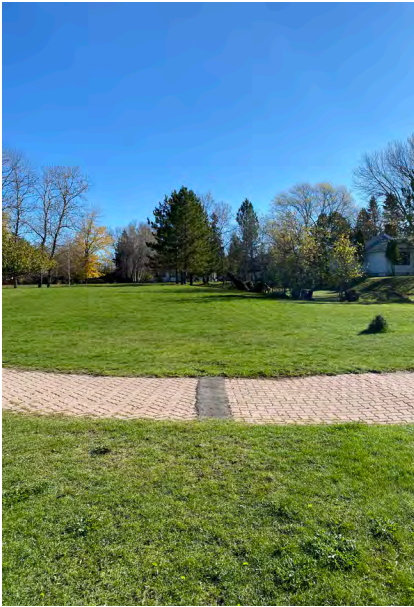
Photo 5: Asphalt patch on trail

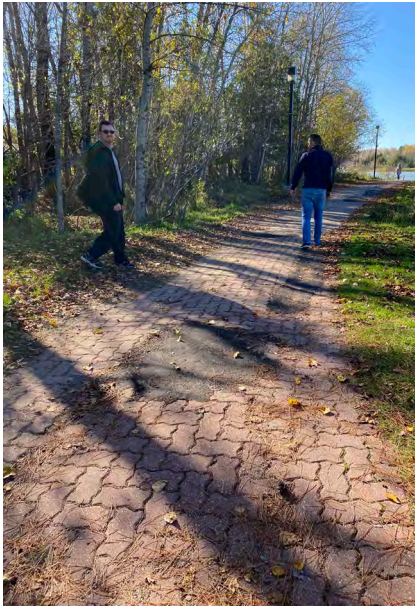
Photo 6: Uneven section of trail

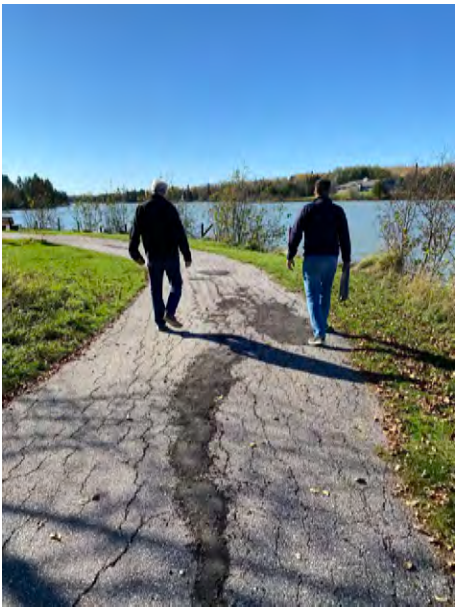
Photo 9: Uneven areas of asphalt trail

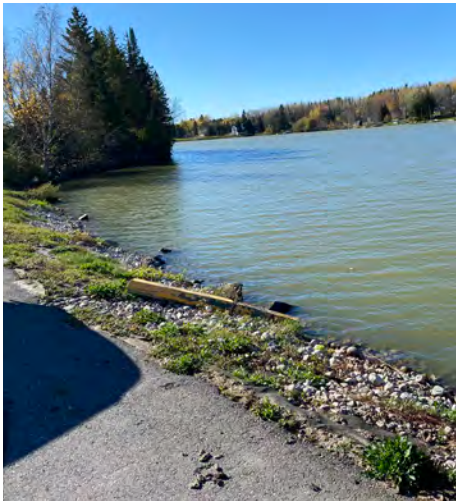
Photo 11: Curb stops pushed into river

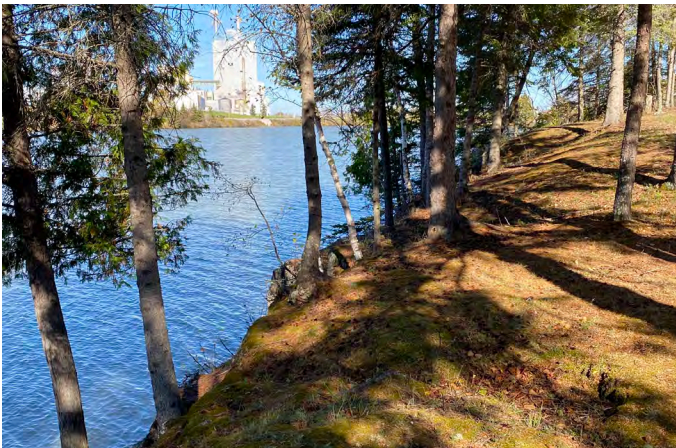
- Pathway moves to the roadway shoulder as it heads south - rocky edge/cliff is dangerous with very steep slopes that drop off to water below.
- Small 'bump out' areas along the shore line could serve as potential rest areas or look out points to the river.

Photo 13: Rocky cliff, steep slopes

- Provide defined trail either along the roadway or along the water's edge. Mid-bank option is not feasible due to highly variable grades and granite outcrops. Refer to Chapter 6 for more on these options.

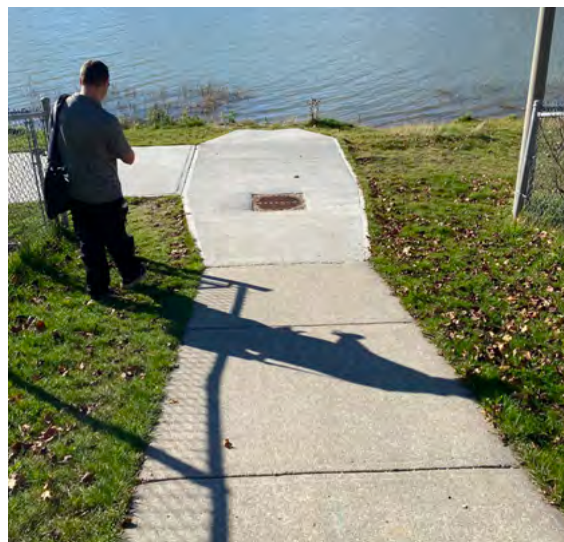
- This section of the trail is on residential roadways - north side along Ross St., south side on River Heights Dr. and then continues south on a dedicated concrete pathway that connects to a pedestrian trail along the shoreline behind private residences.
- Shoreline is flat and ideal for a trail along the water's edge, however this property is privately owned and cut off from the rest of the trail (pedestrians must loop around on River Heights Dr.).
- Trail is very steep from River Heights Dr. down to the pedestrian trail along the shoreline and terminates at the water's edge with no physical barrier to prevent runaway wheelchairs or strollers from continuing down the bank into the river. See Photos 16 and 17.

Photo 17: Steep section of trail

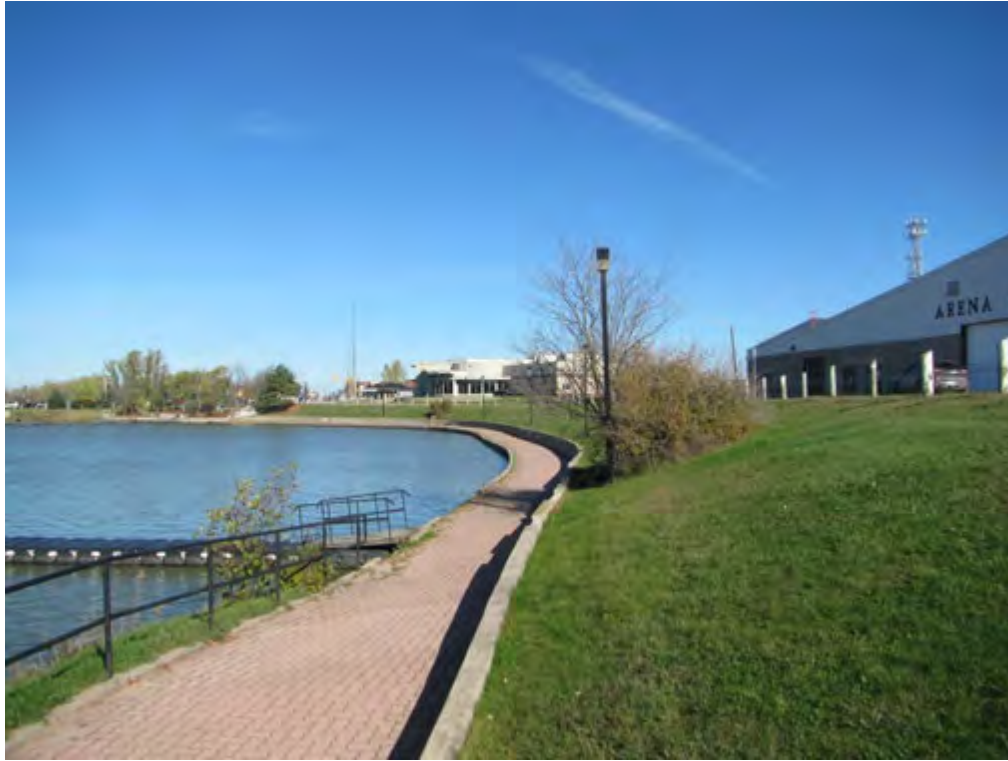
Photo 1: Trail between Duke Street and Arthur Street

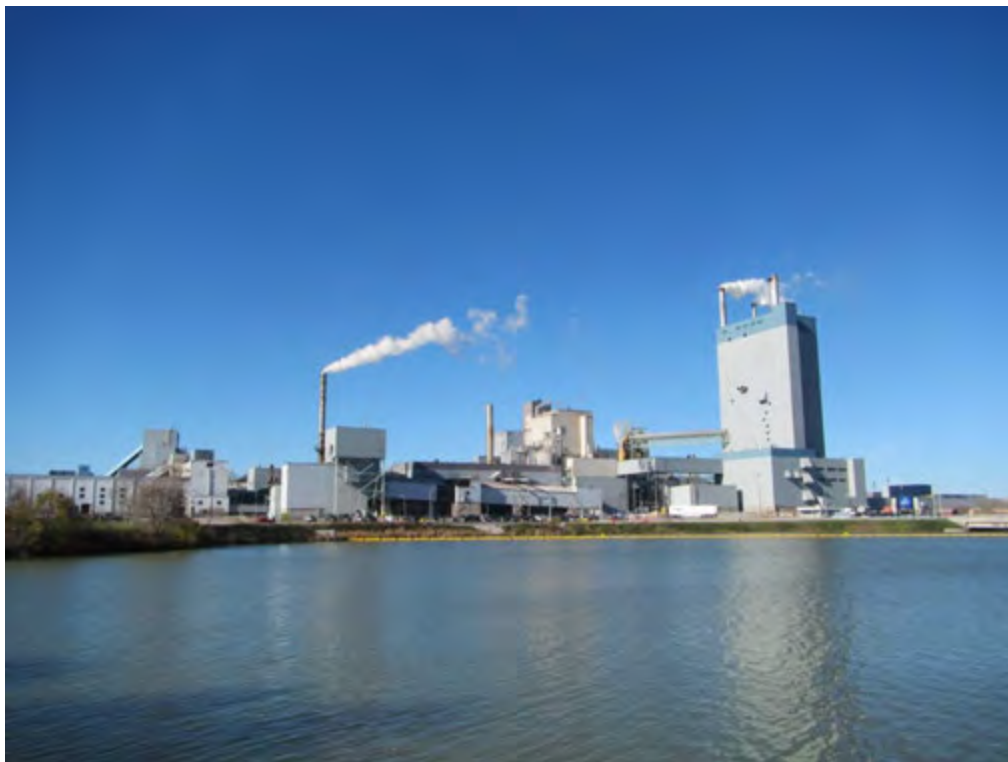
Photo 2: Domtar Pulp Mill across the Wabigoon River

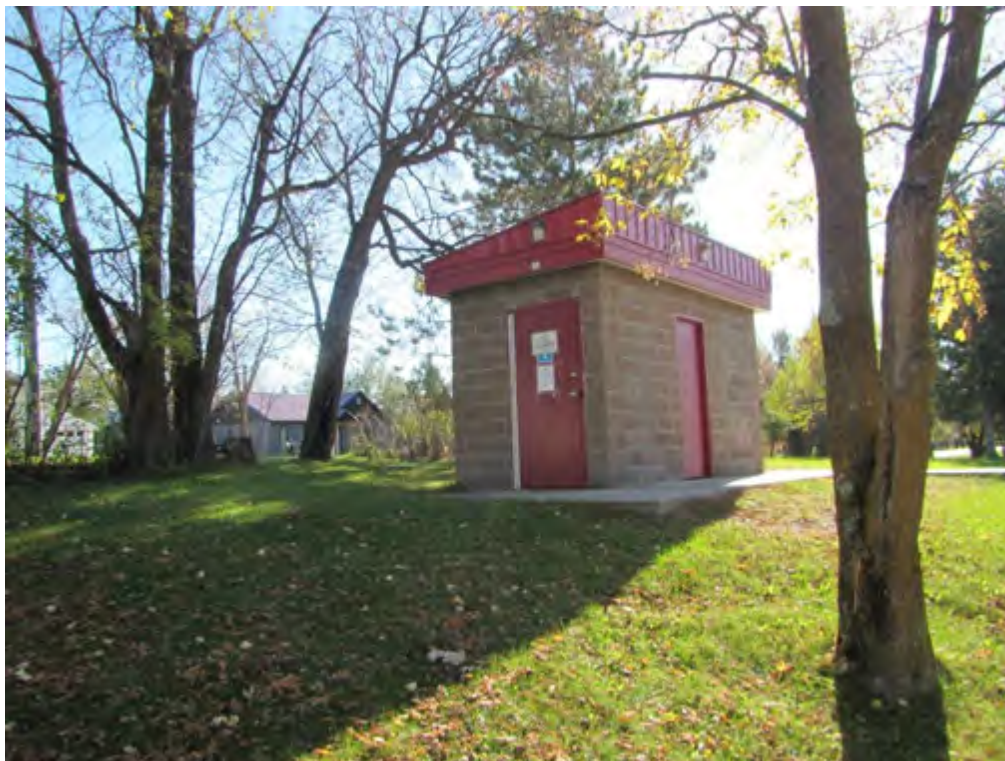
Photo 3: Washroom Building near Cooper Park

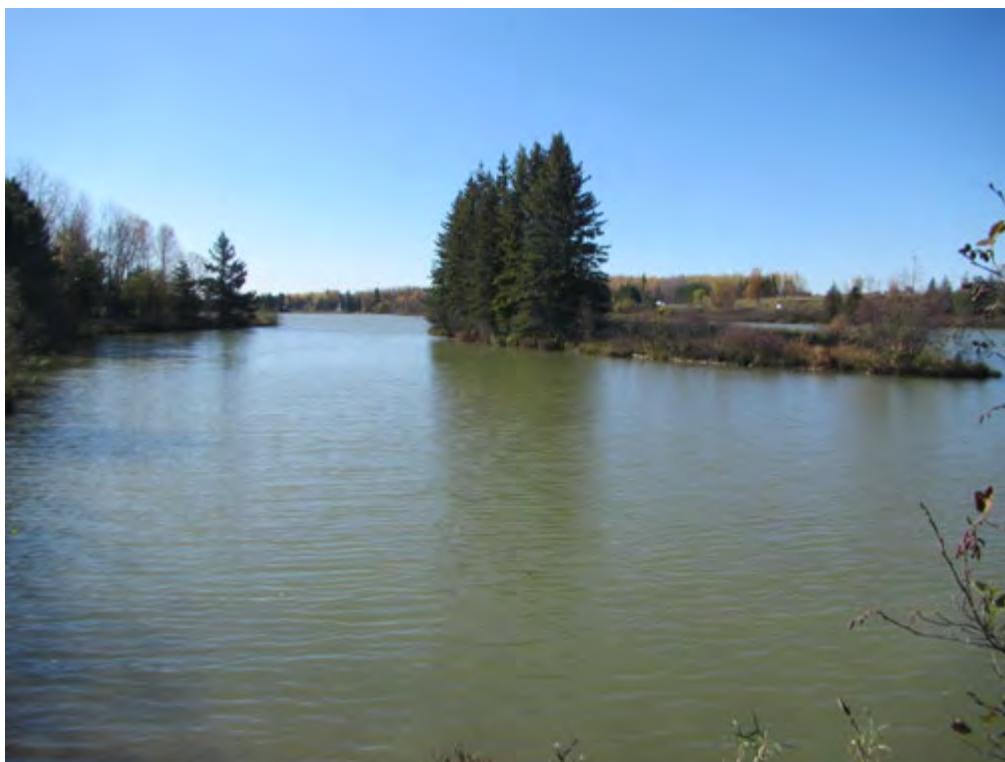
Photo 4: Cooper's Island

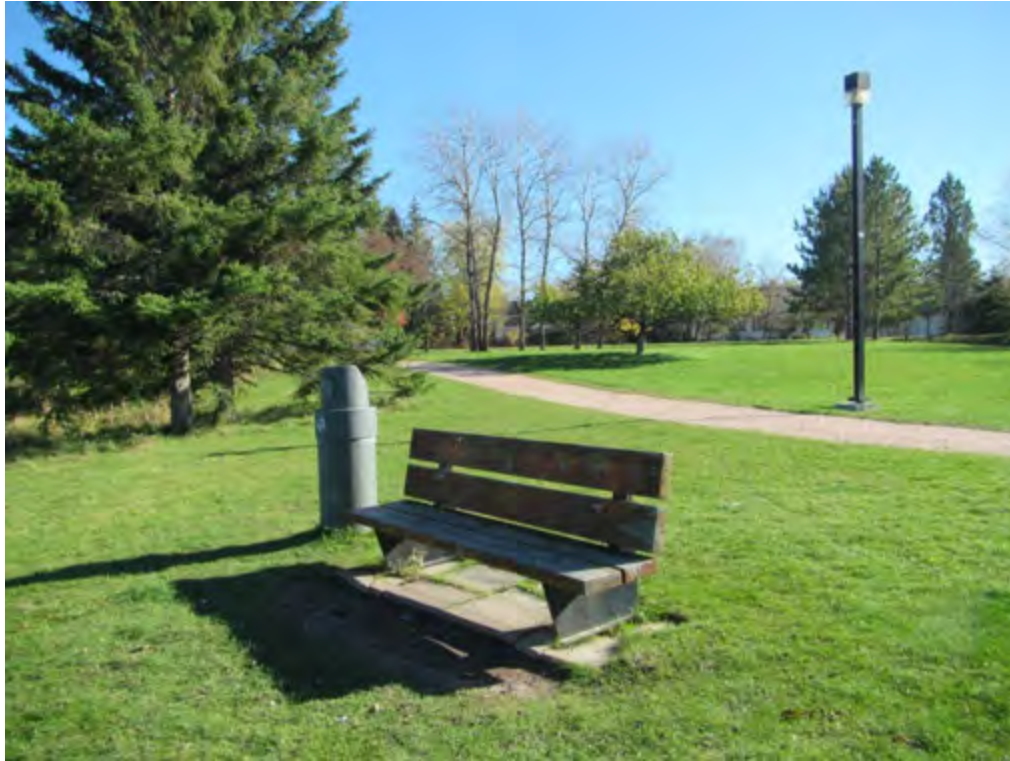
Photo 5: Bench and Waste Bin along Trail between Arthur Street and Victoria Street

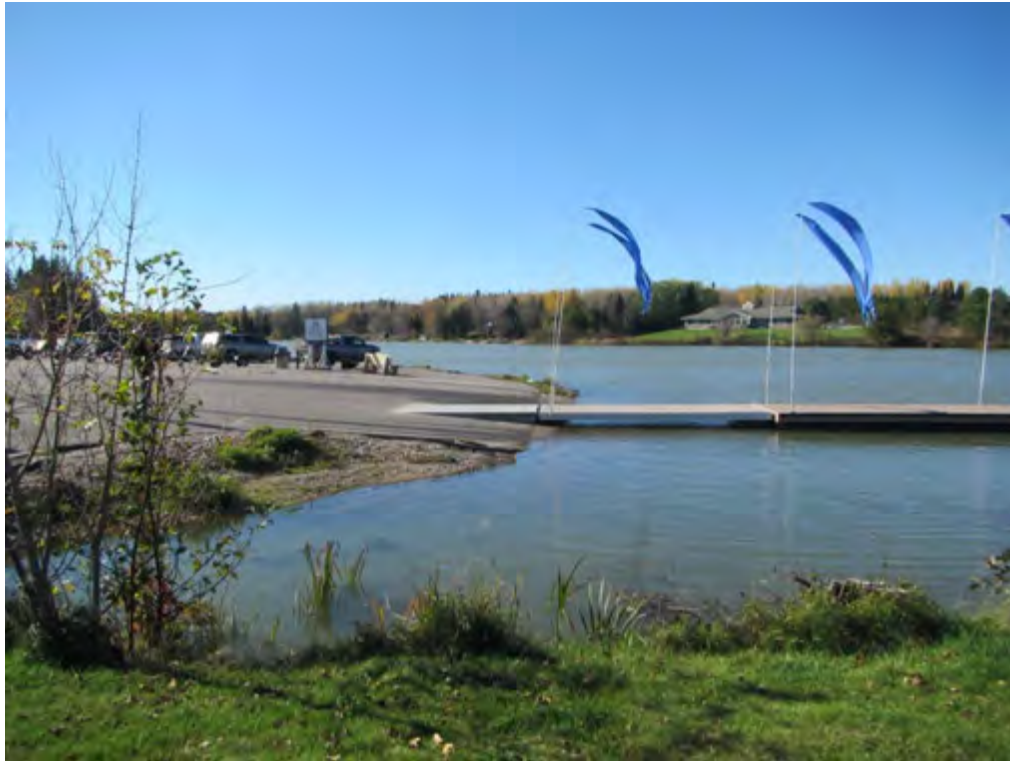
Photo 7: Skene Landing

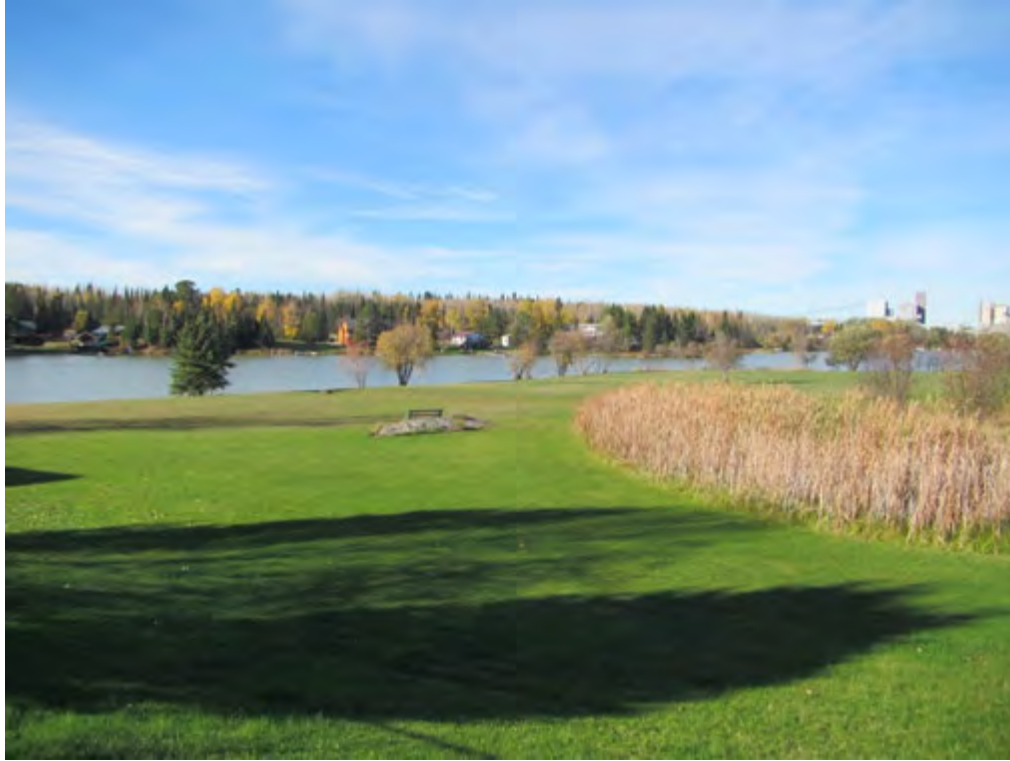
Photo 9: Private Park between Riverview Drive and Edgewater Drive

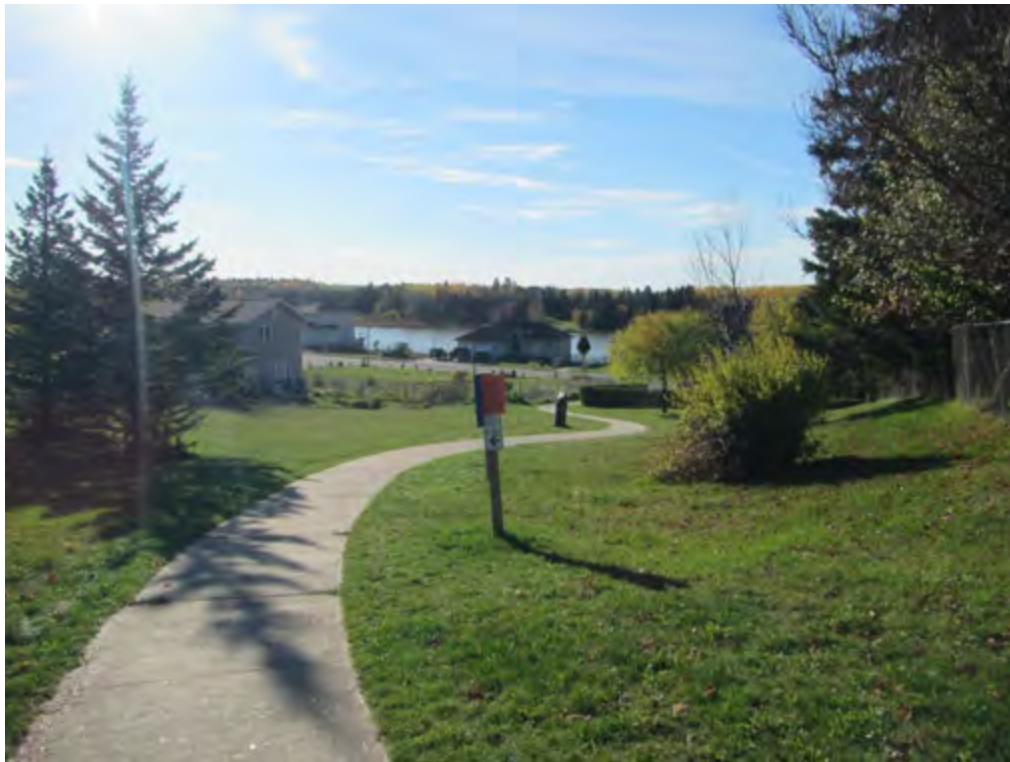
Photo 10: Path between River Heights Drive and Edgewater Drive

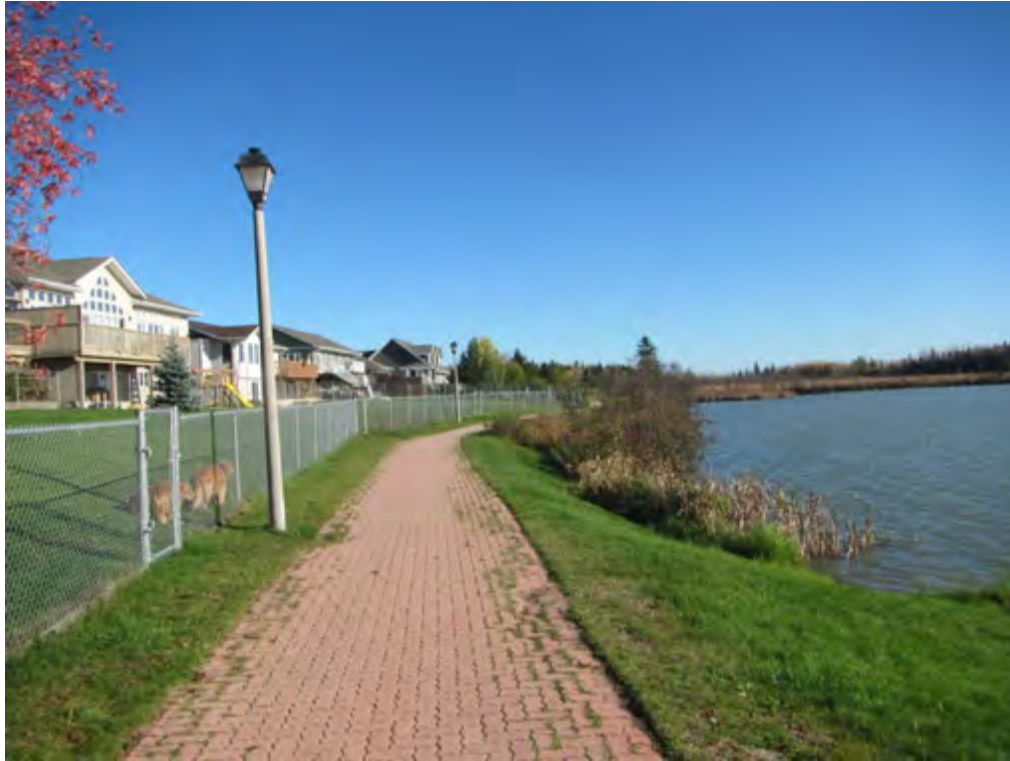
Photo 11: Trail Section along Edgewater Drive

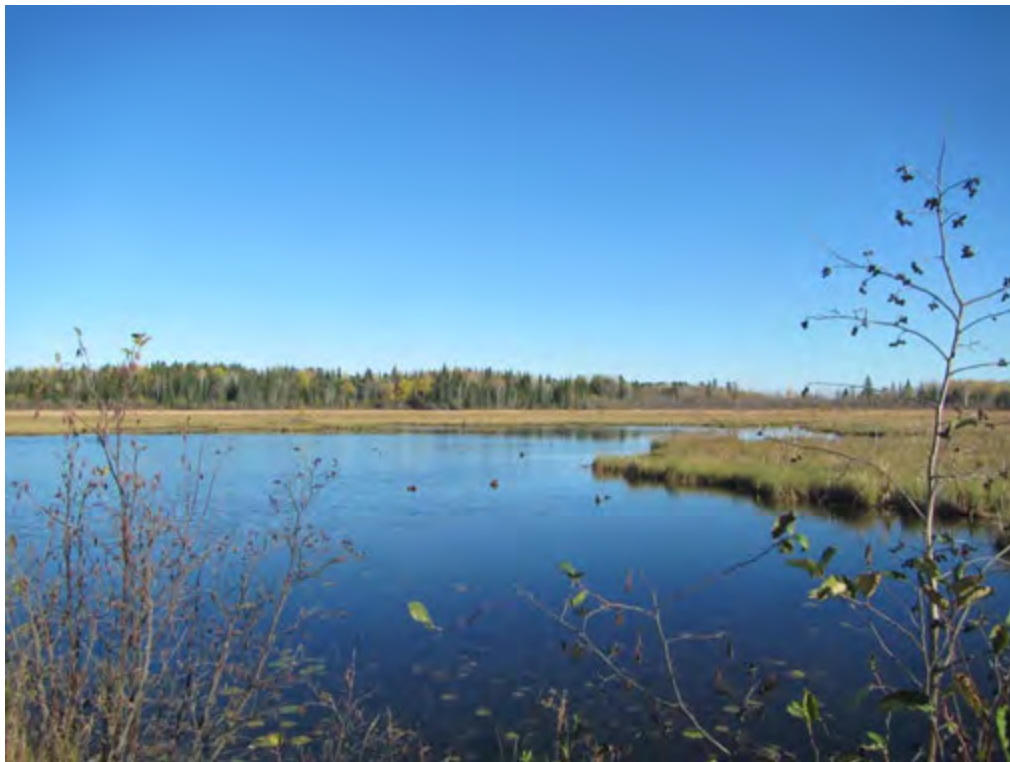
Photo 12: Laura Howe Marsh

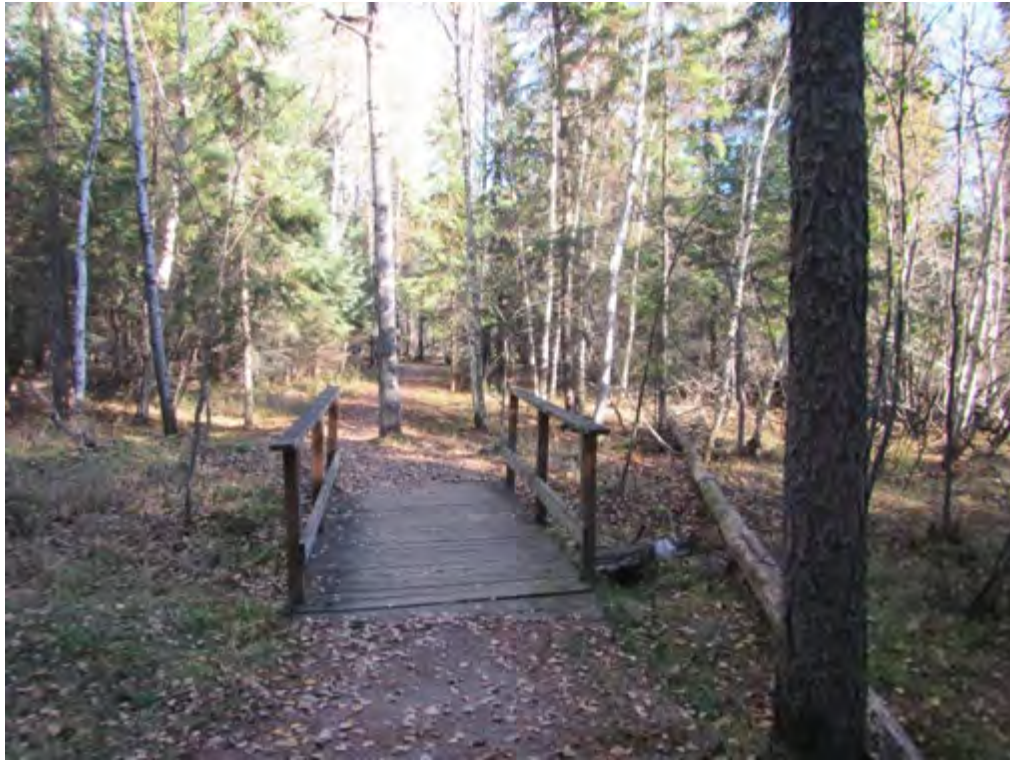
Photo 13: Pedestrian Bridge along the Marsh Trail System

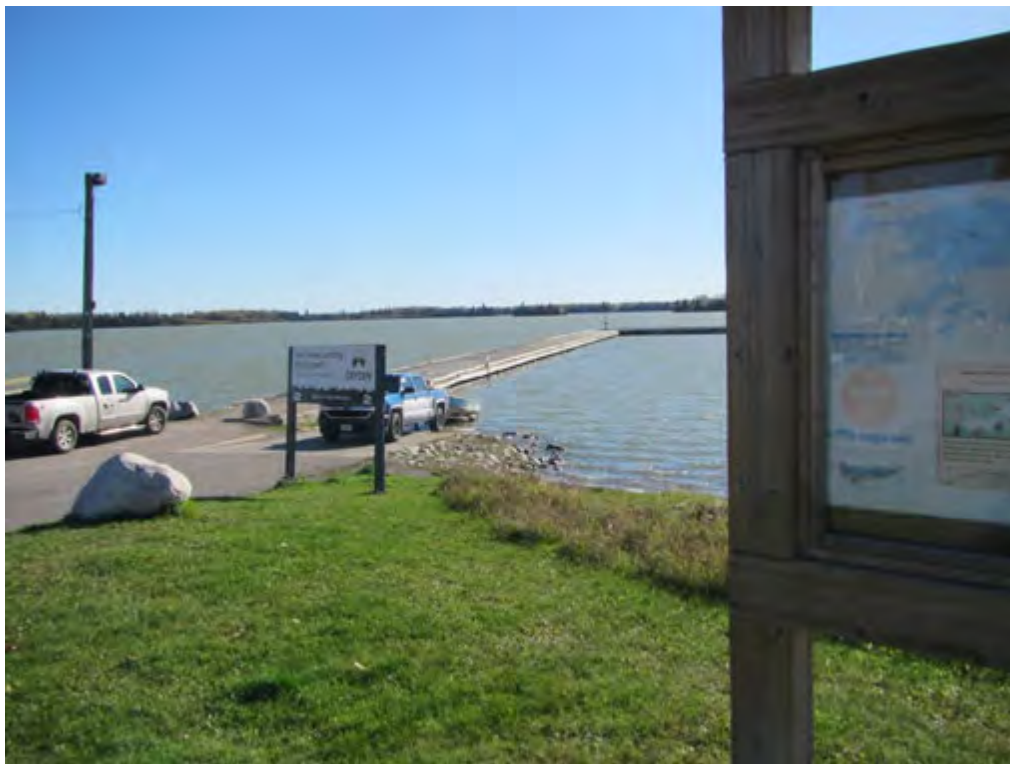
Photo 14: Van Horne Landing

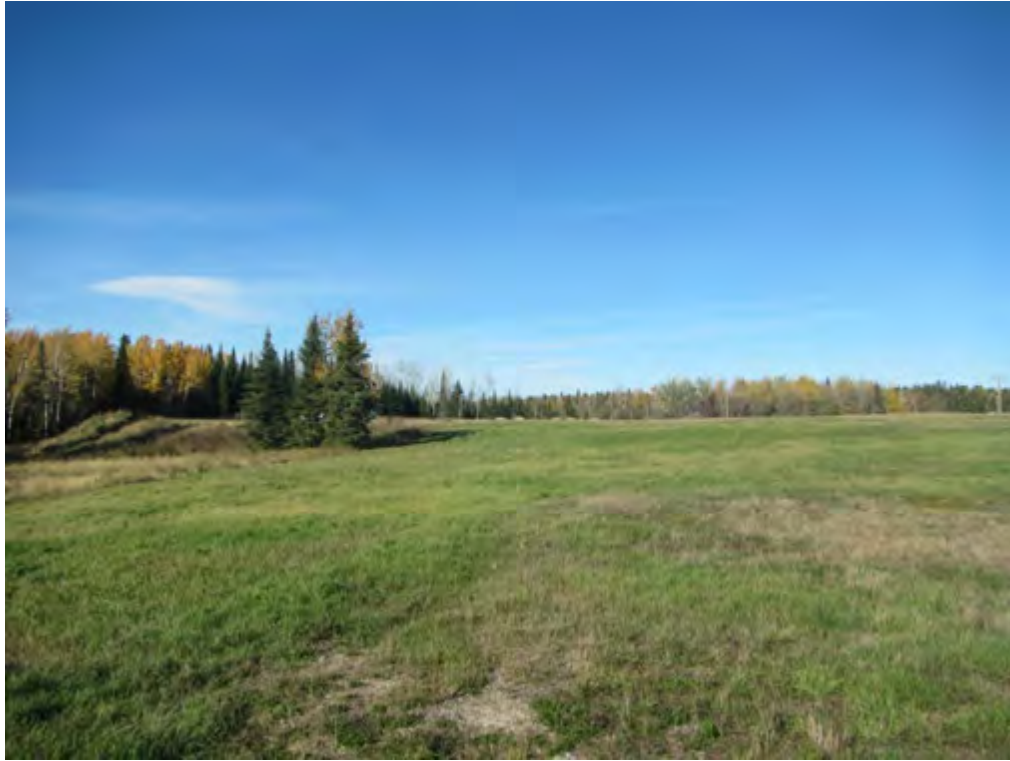
Photo 15: Field between the Marsh Trail and Van Horne Landing

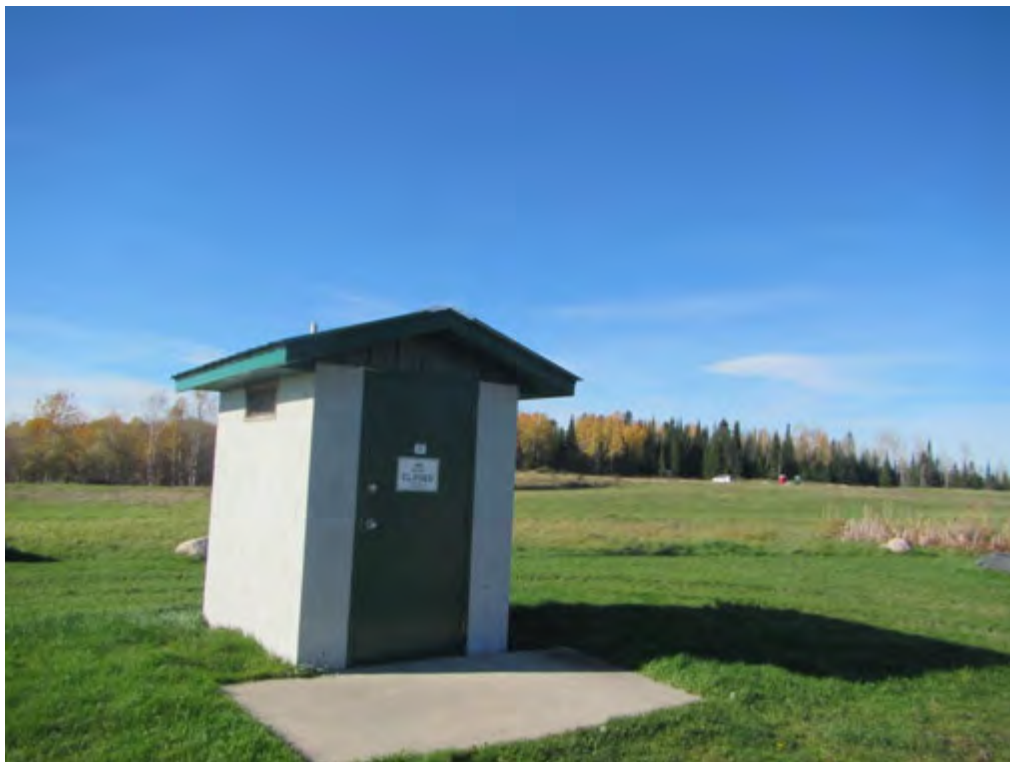
Photo 16: Washroom Building at Van Horne Landing
